# Ho Chi Minh Highway Fourteen Years Later

(2000- 2014)

*A Photo Essay on the Role of Vetiver System in Controlling Erosion on the Highway Following a Visit in February 2014*

**Dr. Paul Truong**

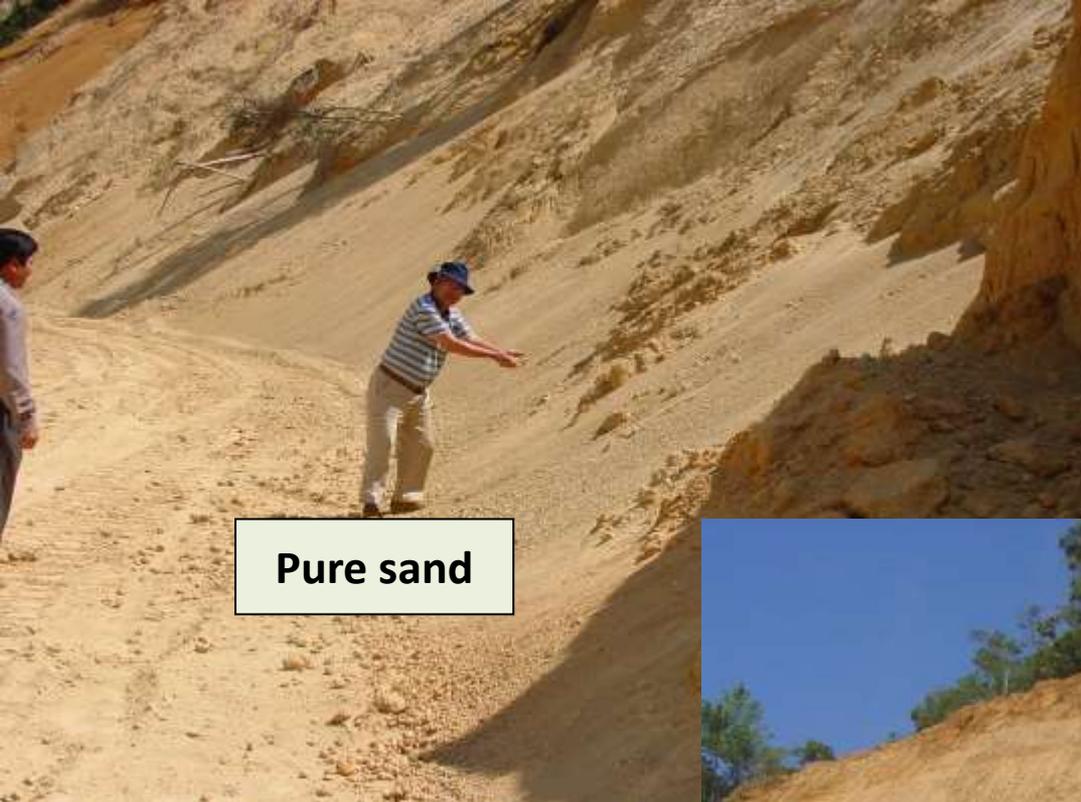
Pure sand

**Very steep cutting and no benches or drainage channels**

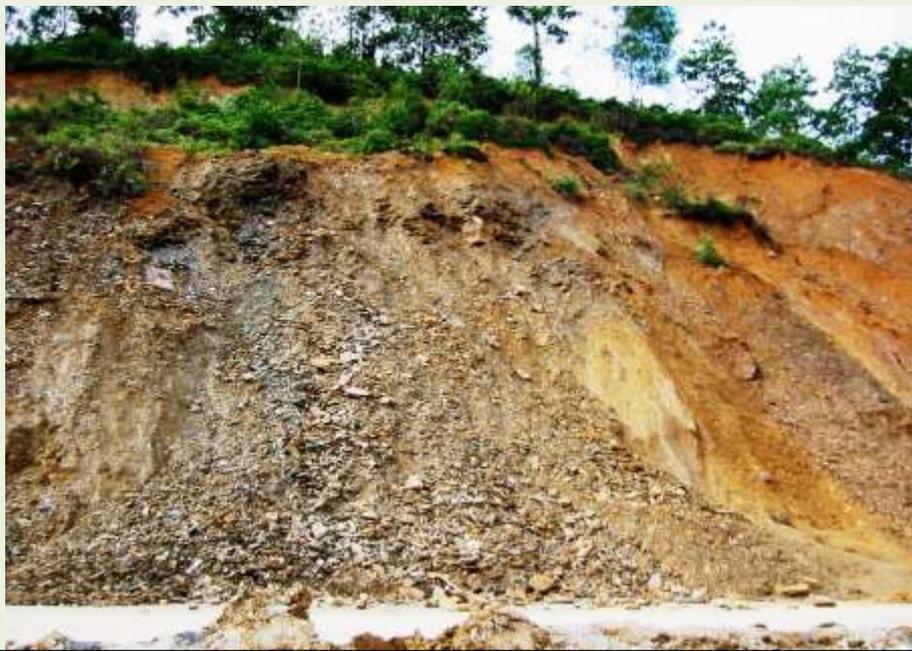
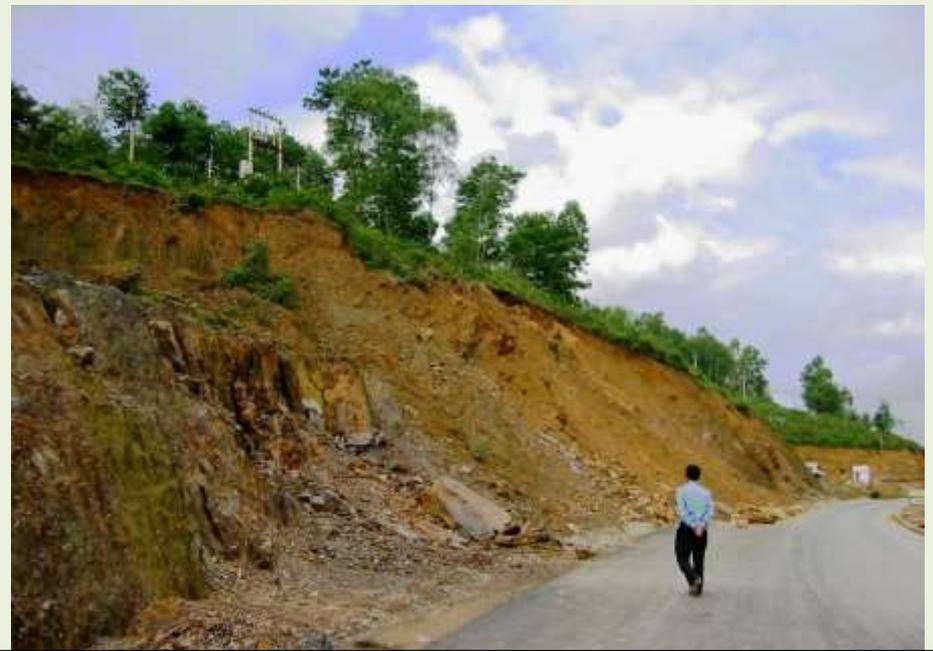
**Erosion started while bitumen paving in progress**

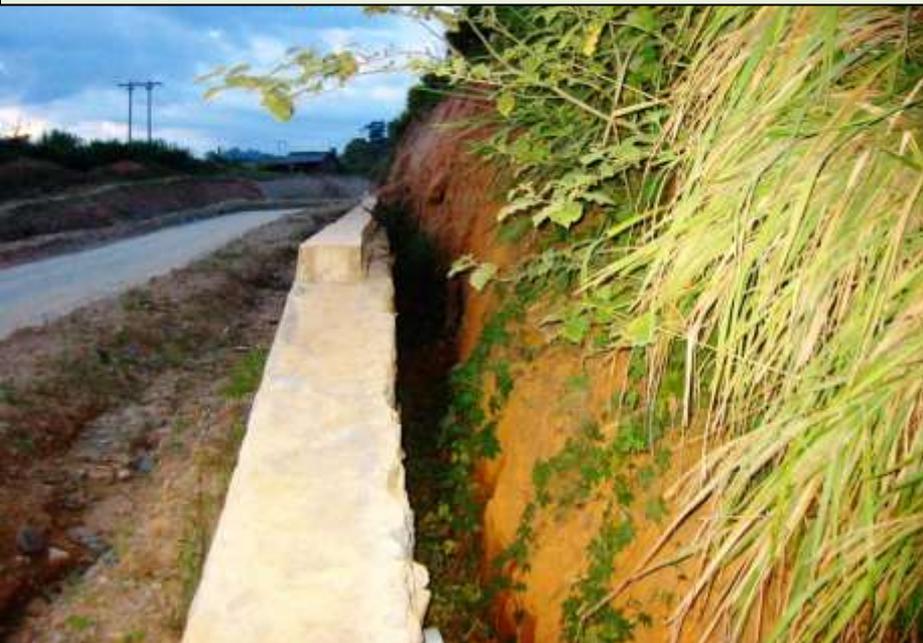
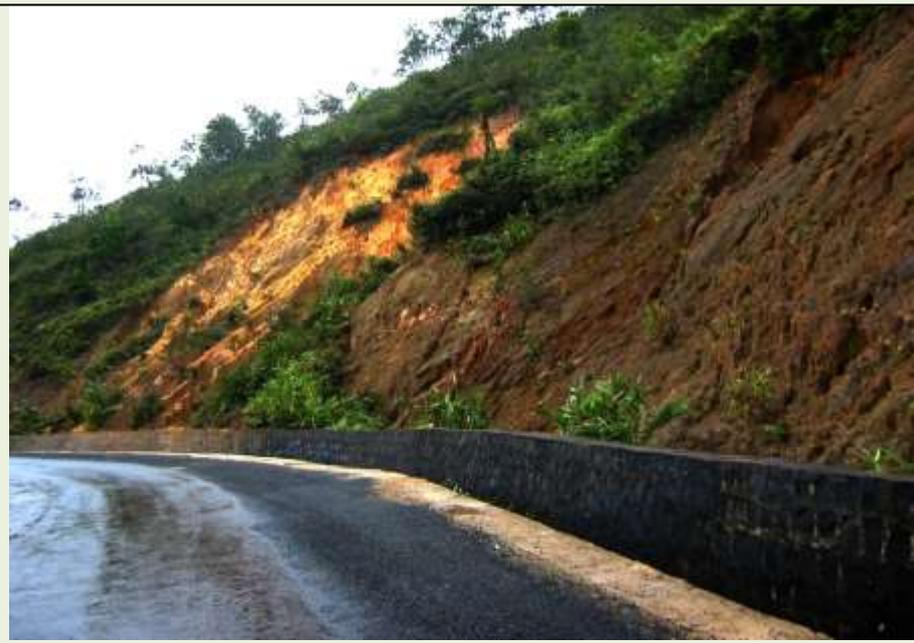
**Conventional hard structure solution: Small and large retaining walls**

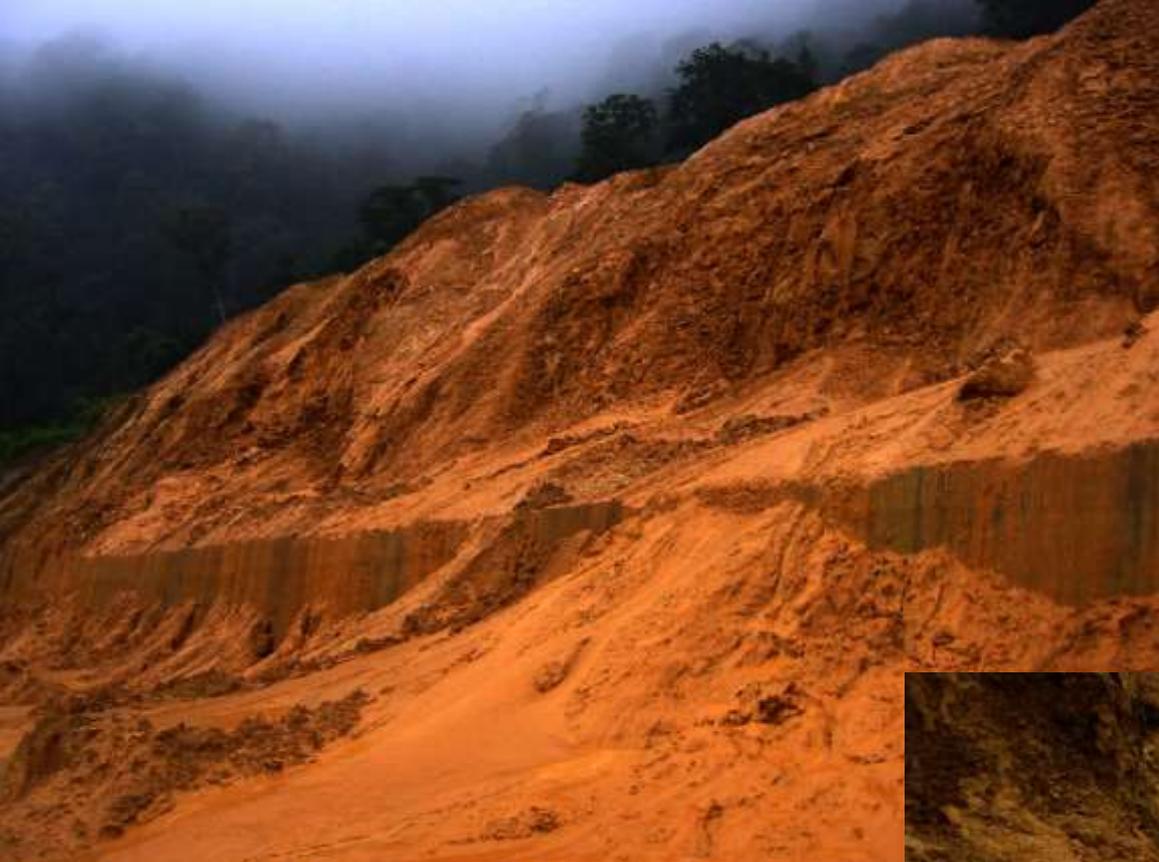
**But these massive and costly retaining walls by themselves did not stop erosion during the typhoon season**

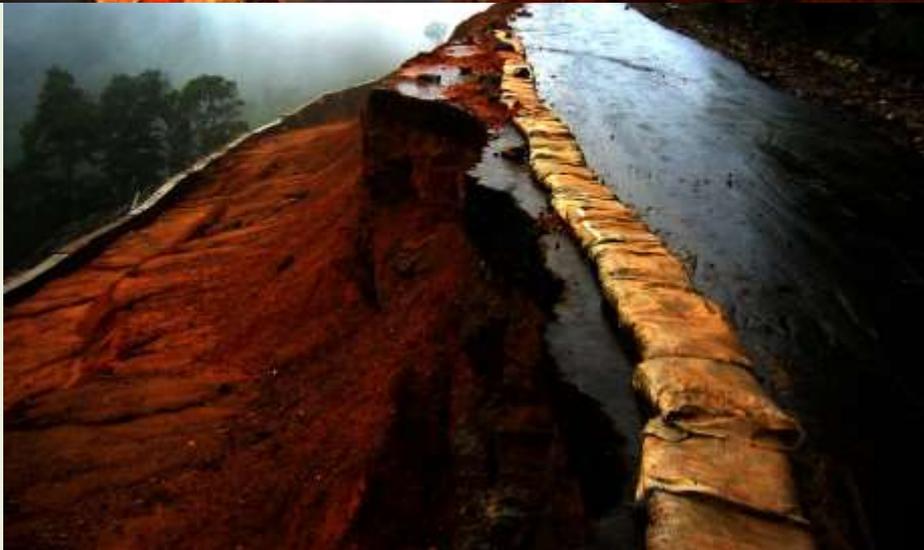
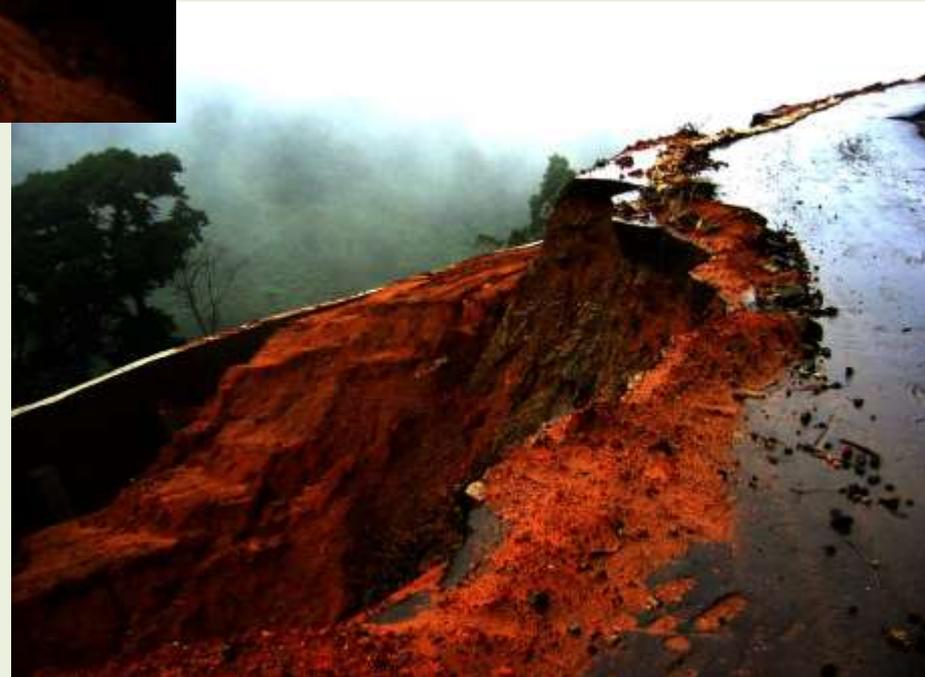
**If unprotected, this was what happened during the typhoon season**

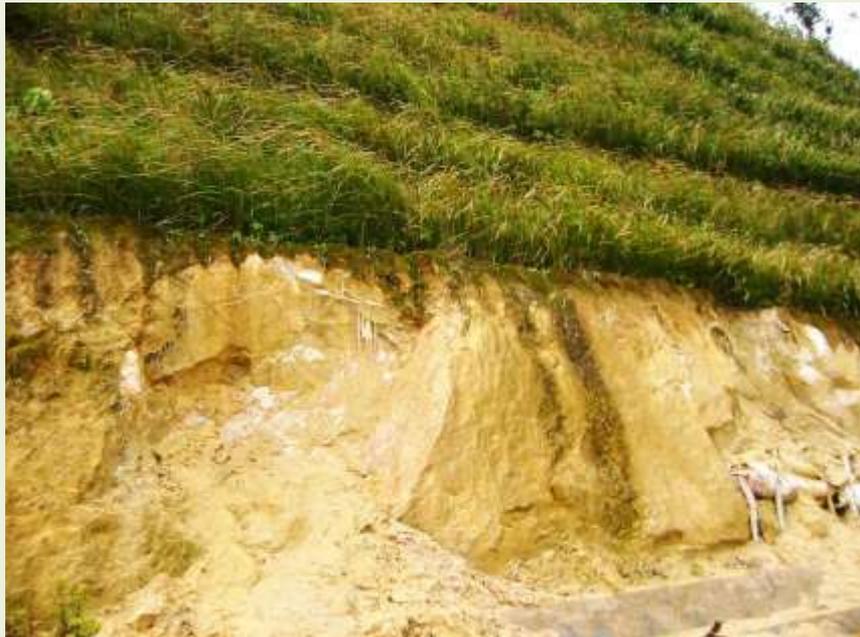
Another look at the steep shattered slope toe.

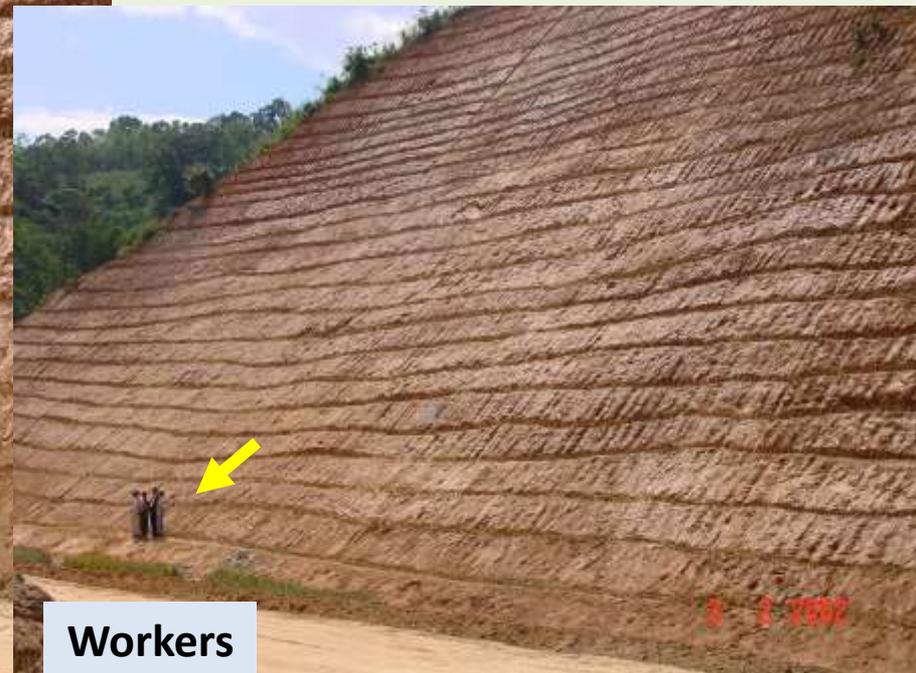
**Workers**

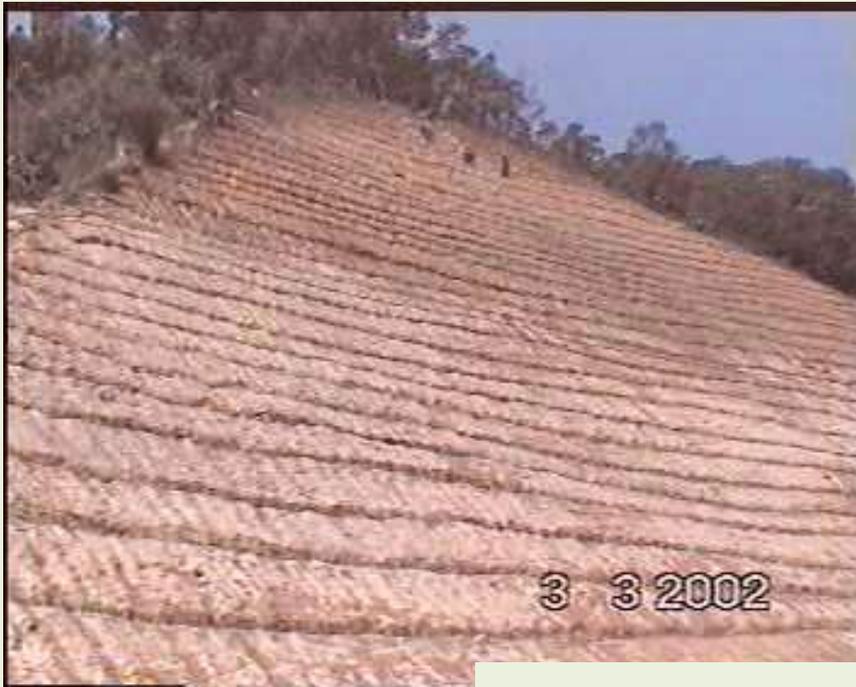
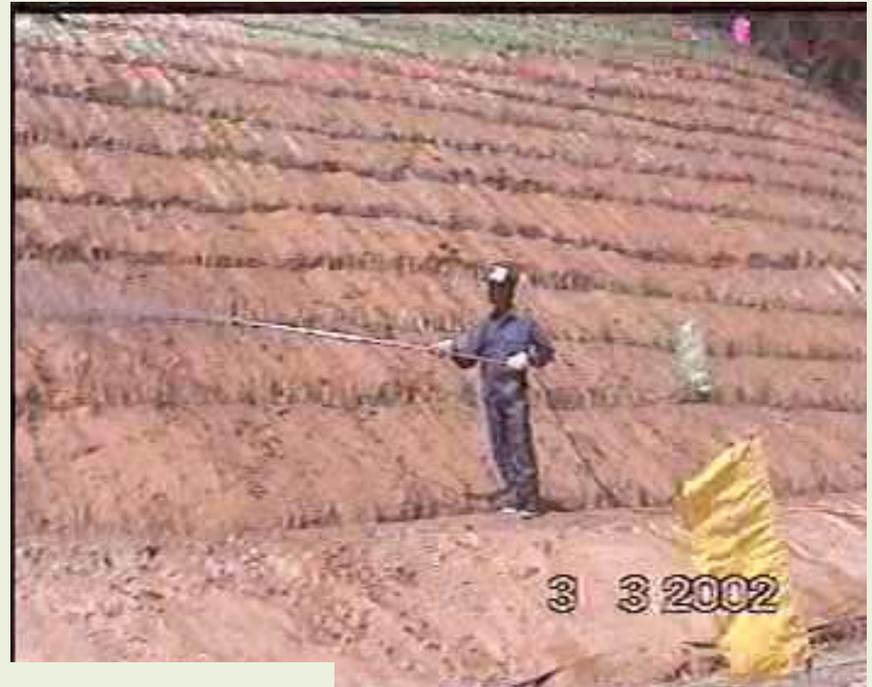
One month after planting

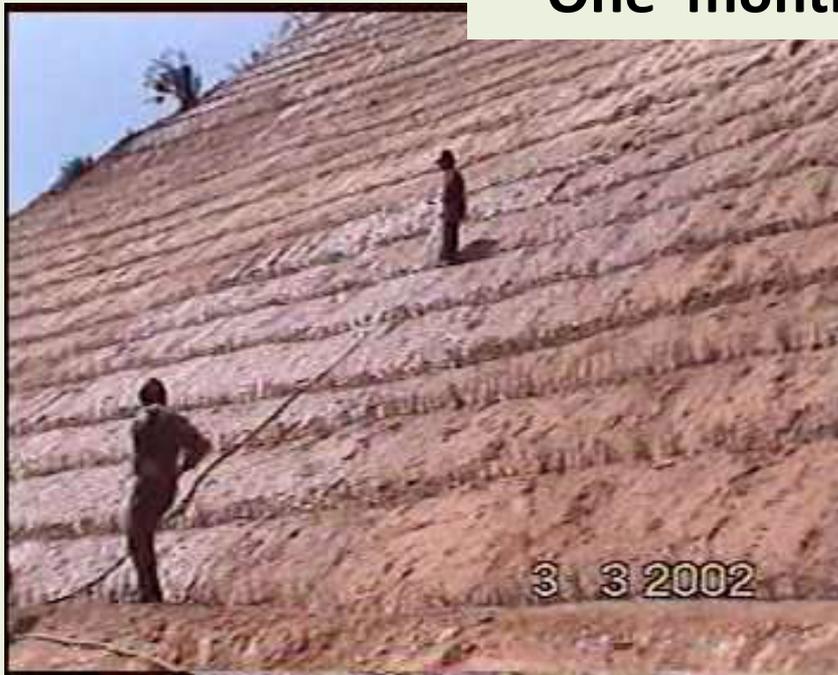
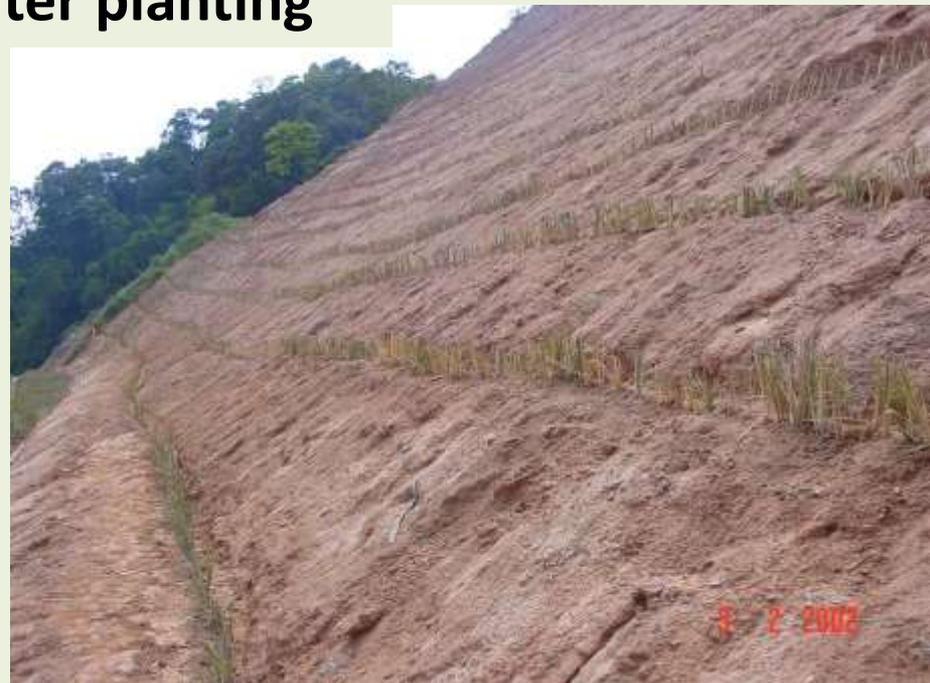
**Despite badly designed (no benching and Internal drainage), this very steep batter was successfully stabilized 3 years after planting. Survived several typhoons**

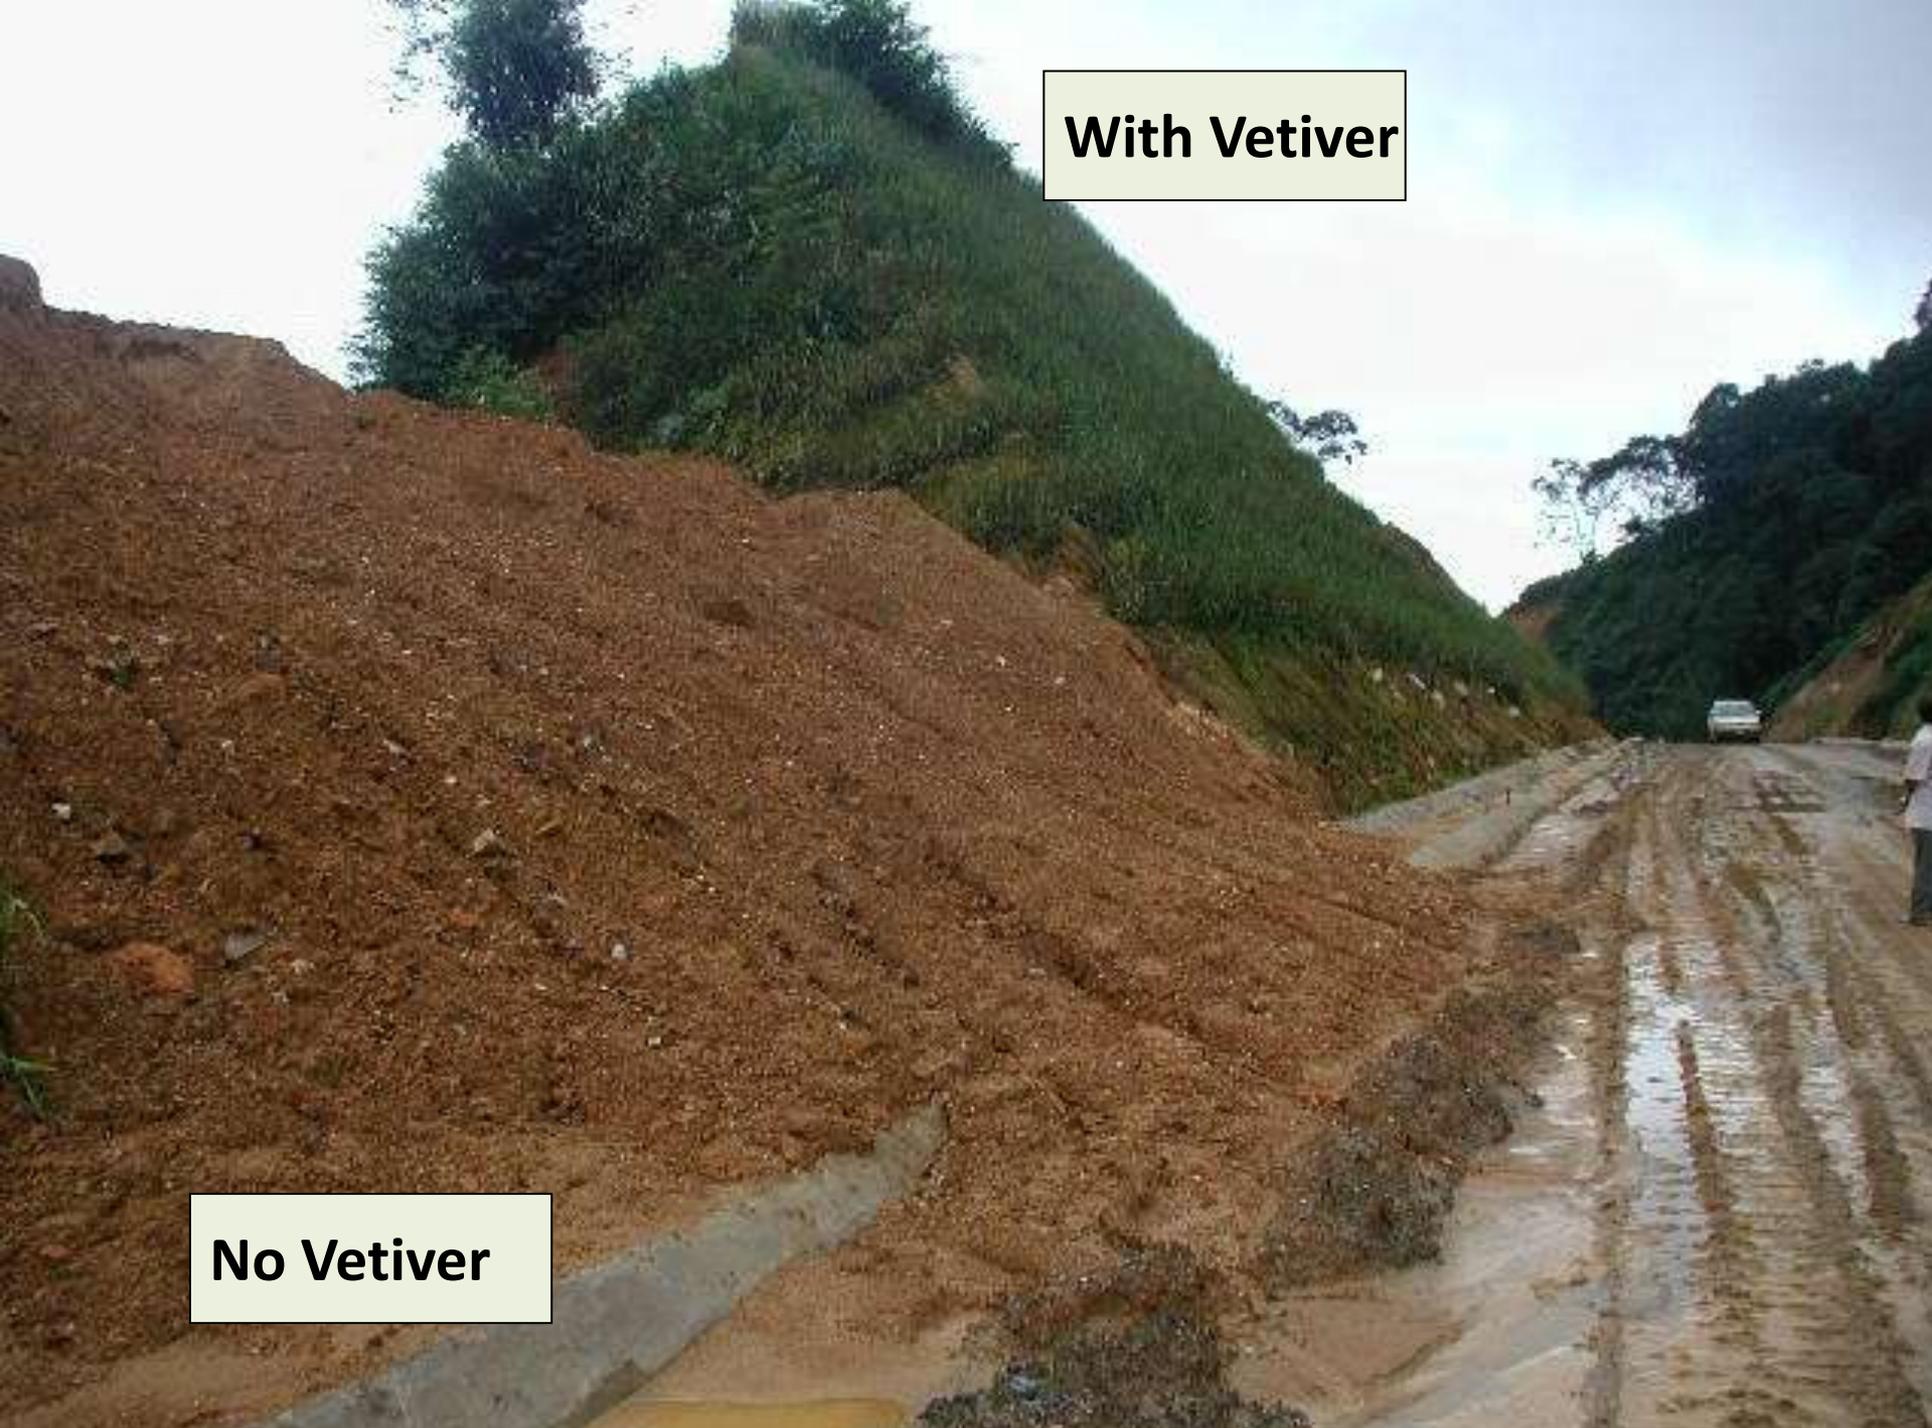
**With Vetiver**

**No Vetiver**

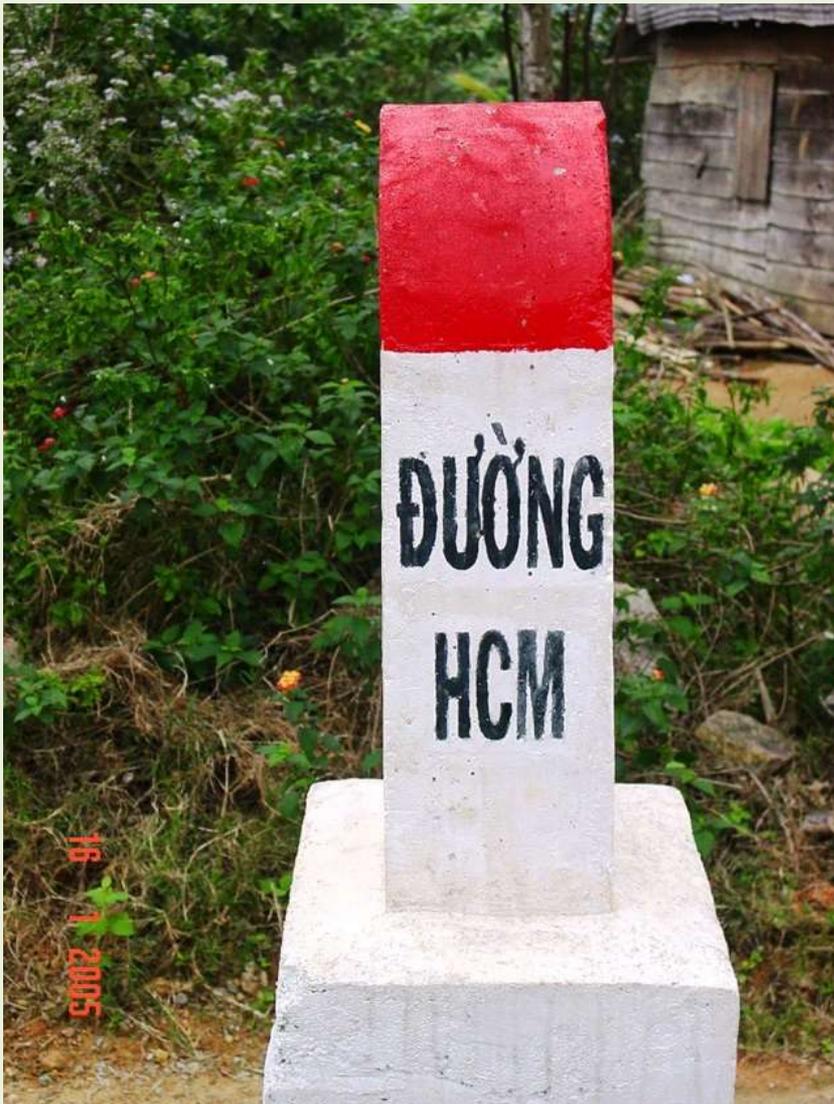
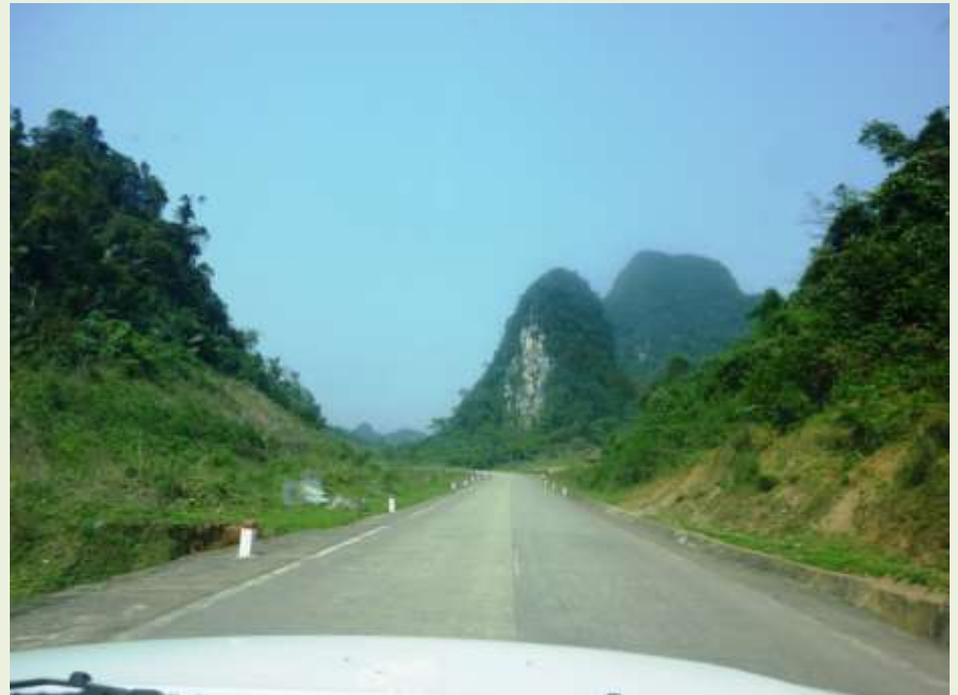
**Over the distance of about 1 000km of Sections 1 and 2 of the HCMHW, stretching over a wide range of geology, topography, altitude and climate, it was very pleasing to note that the Vetiver System has successfully stabilized this highway in general .**

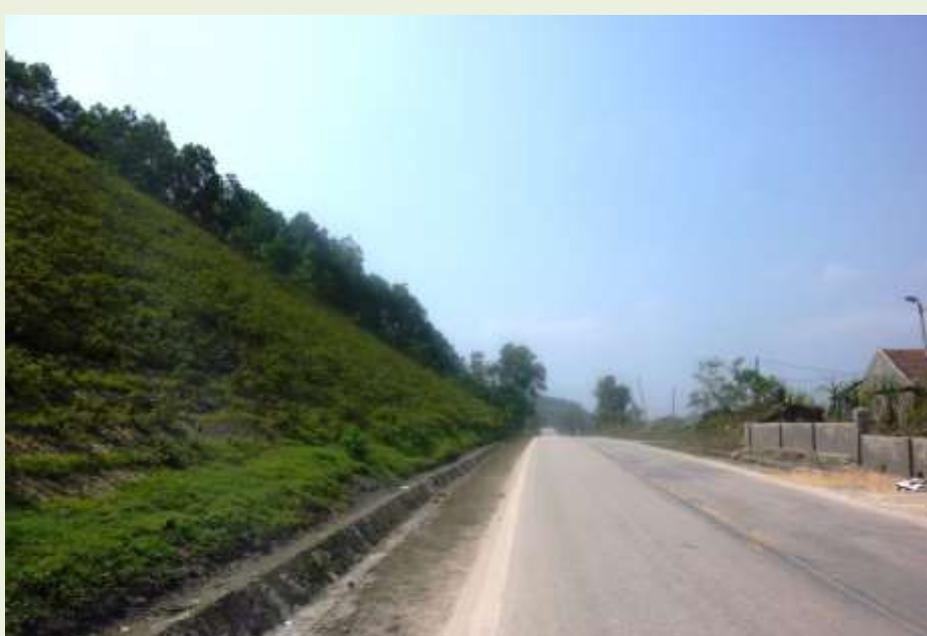
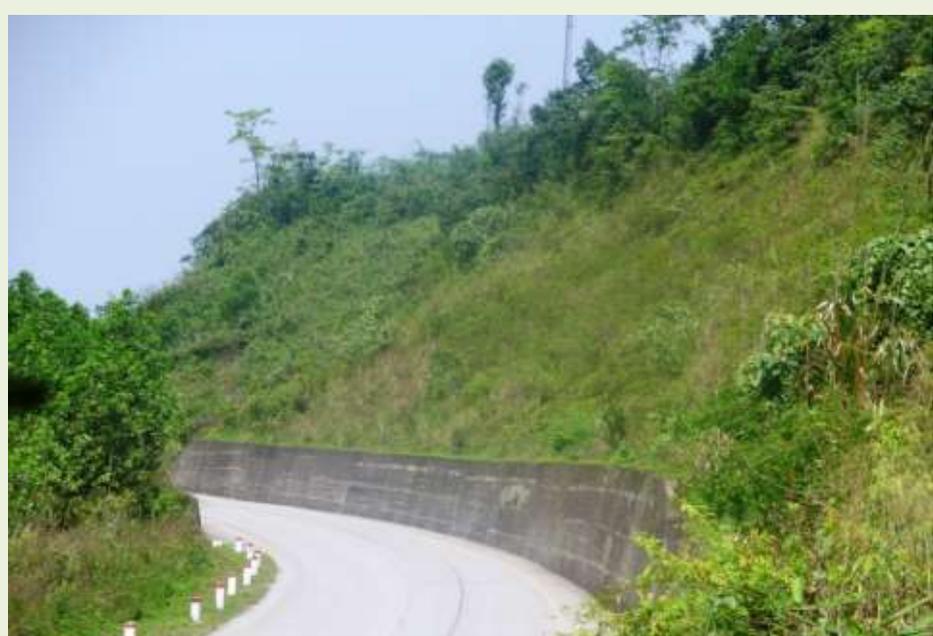
*General view along the Highway in February 2014*

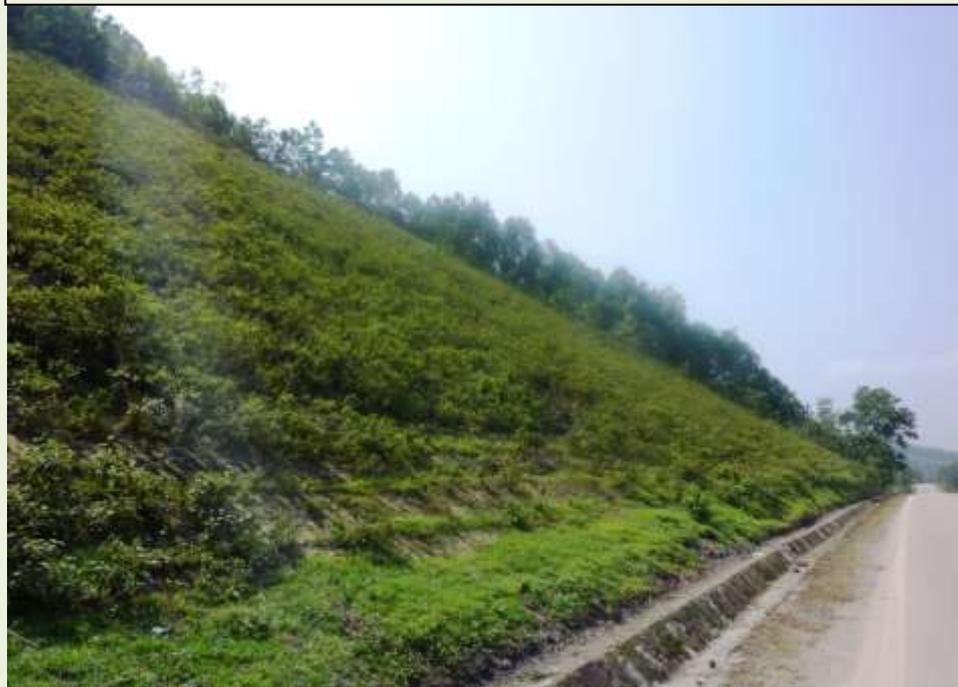
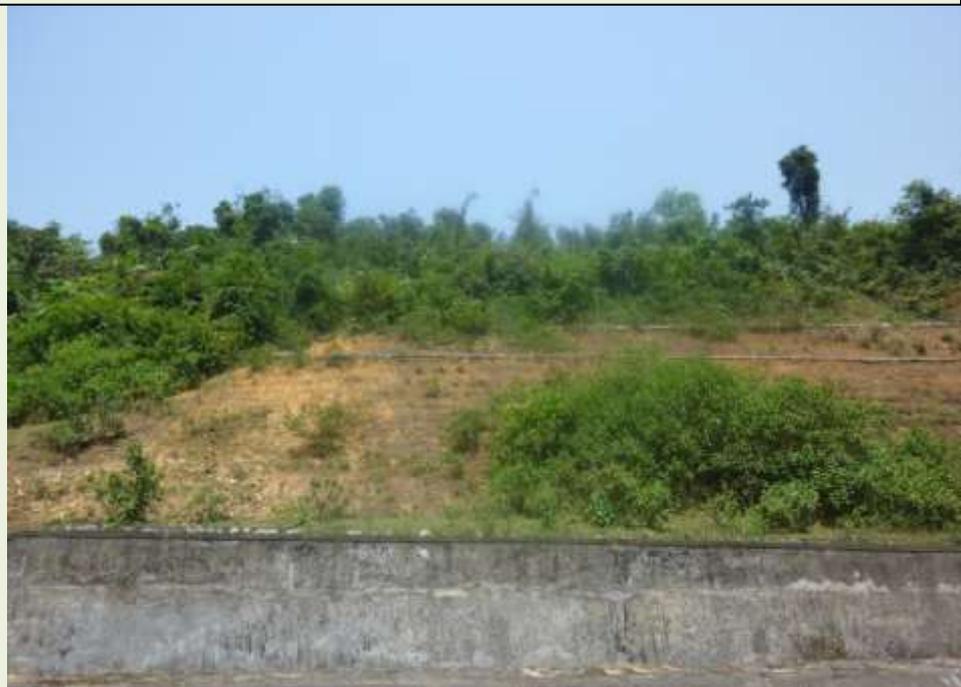
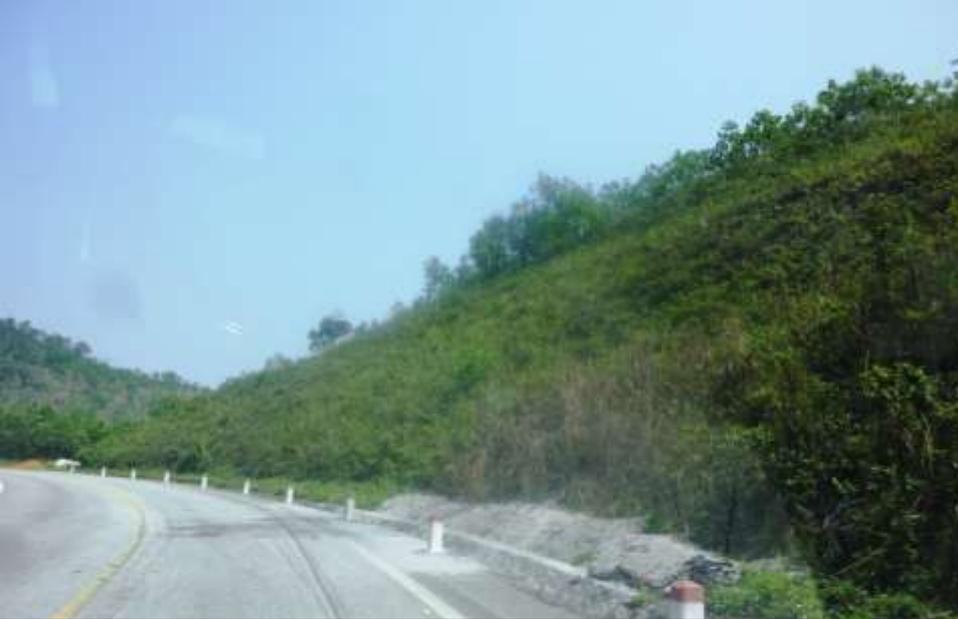
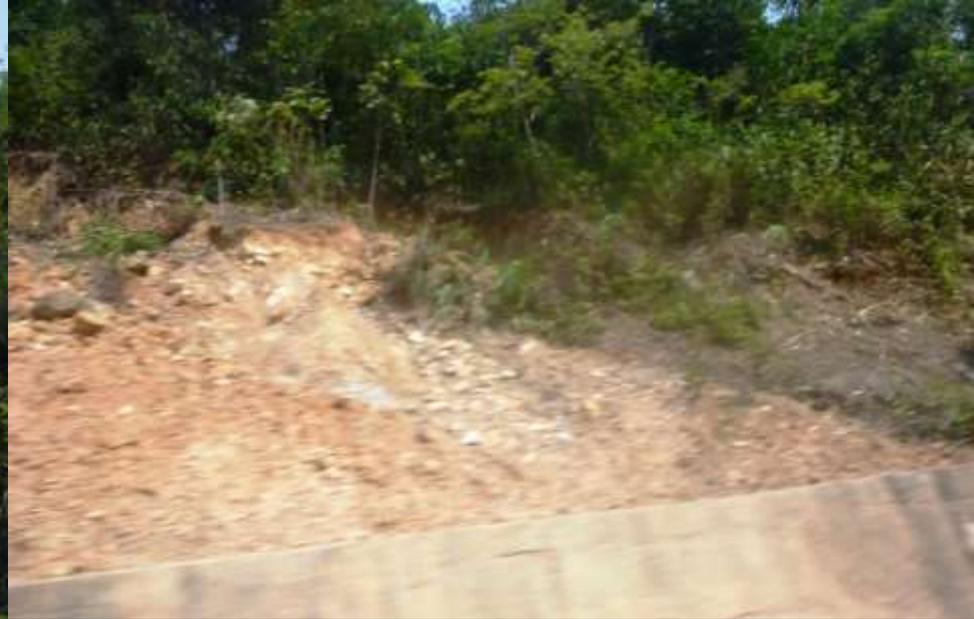
*General view along the Highway in February 2014*

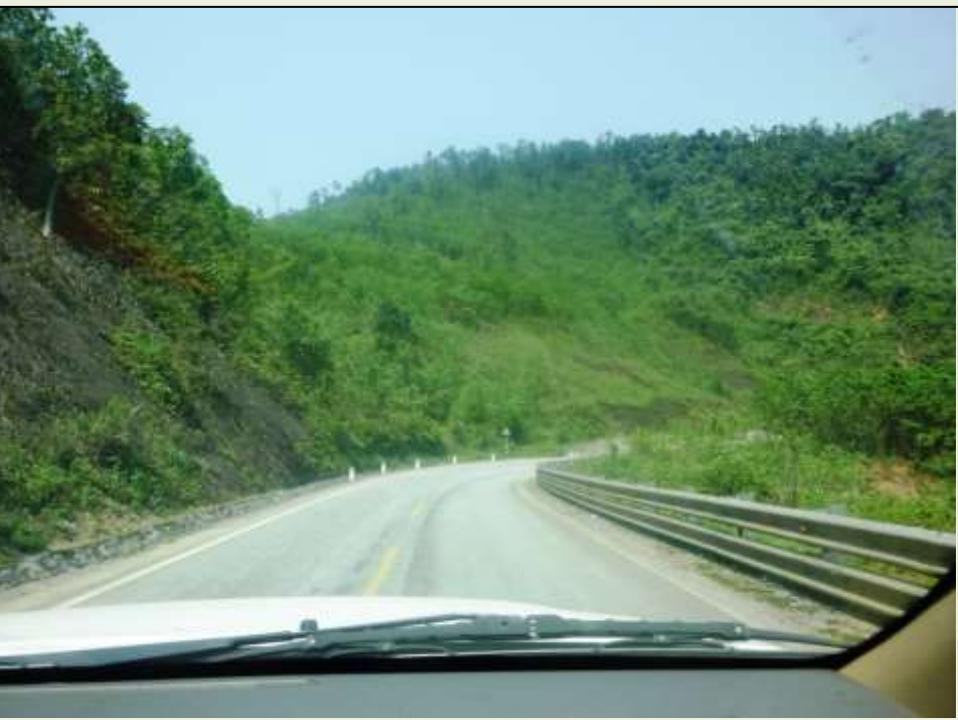
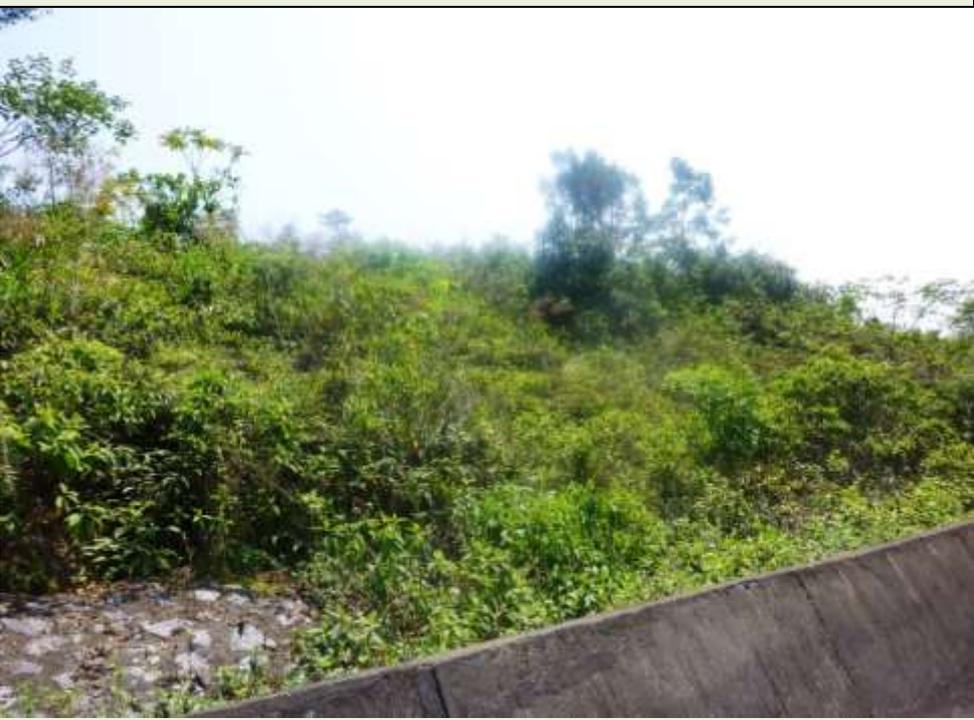
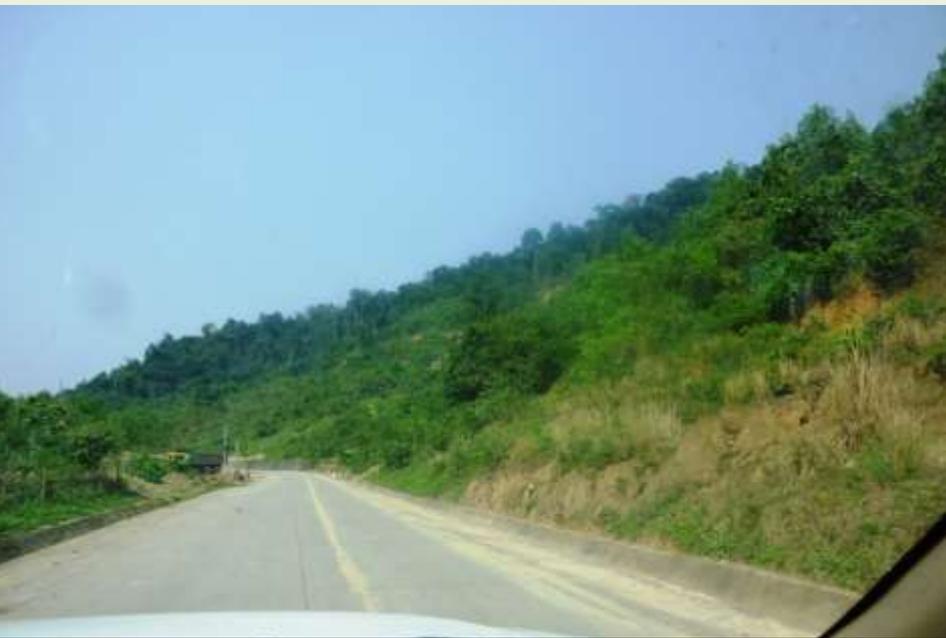
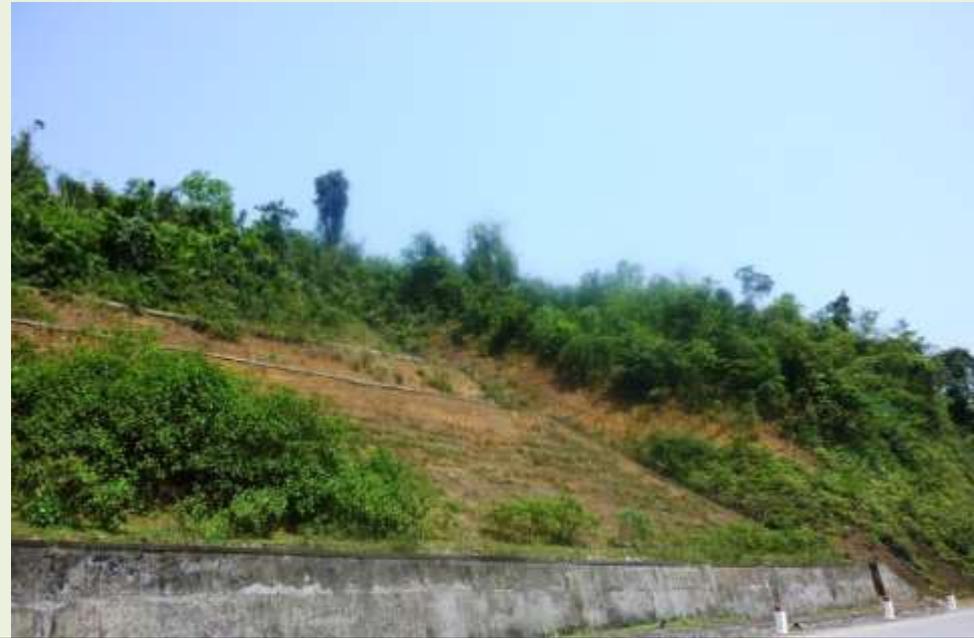
*General view along the Highway in February 2014*

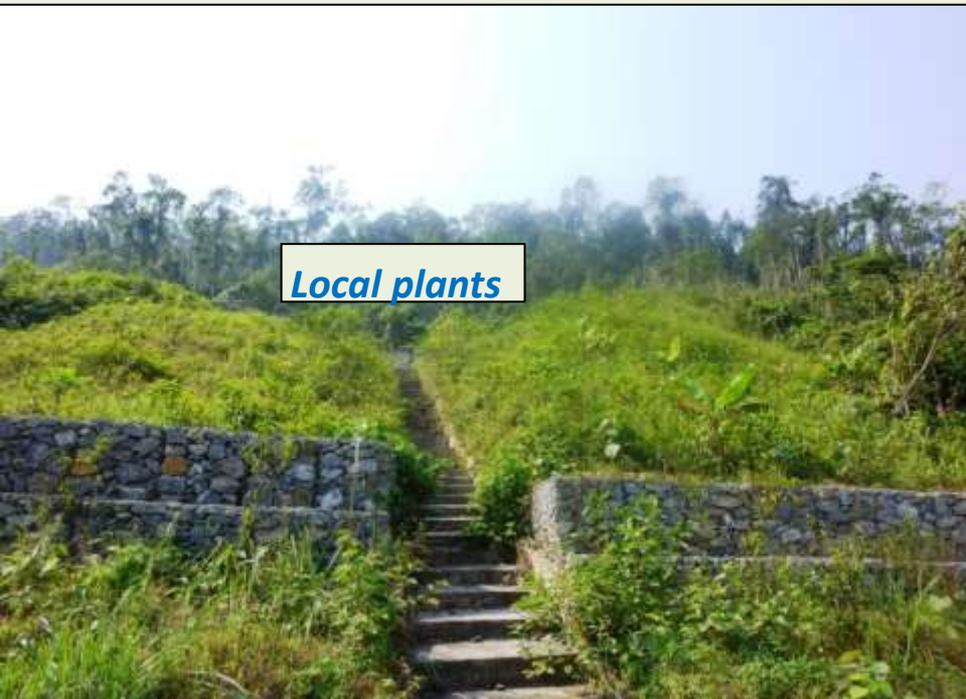
*Local plants*

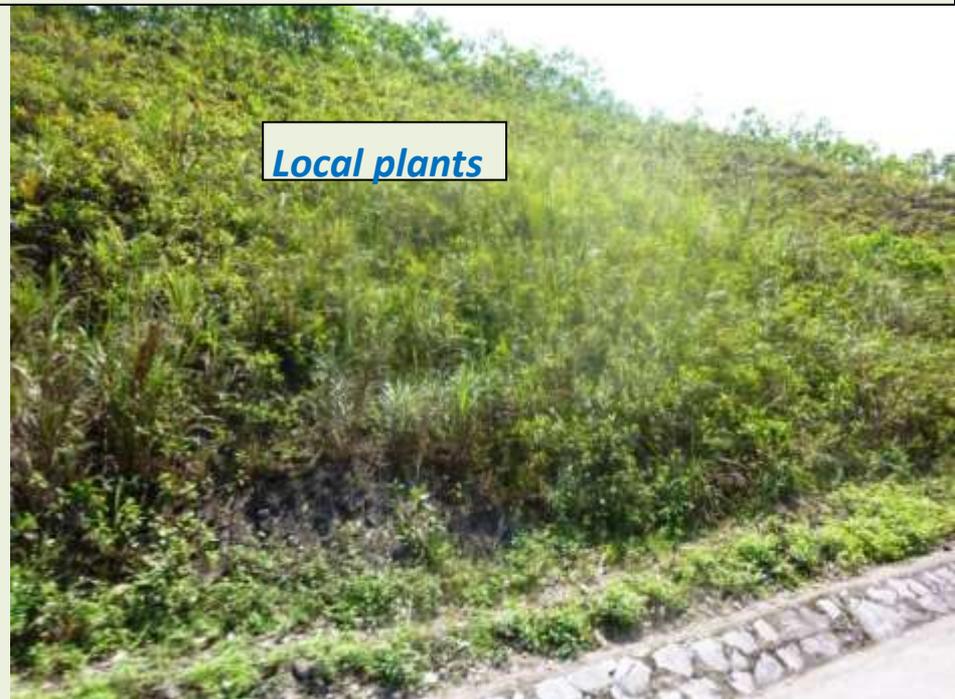
*Local plants*

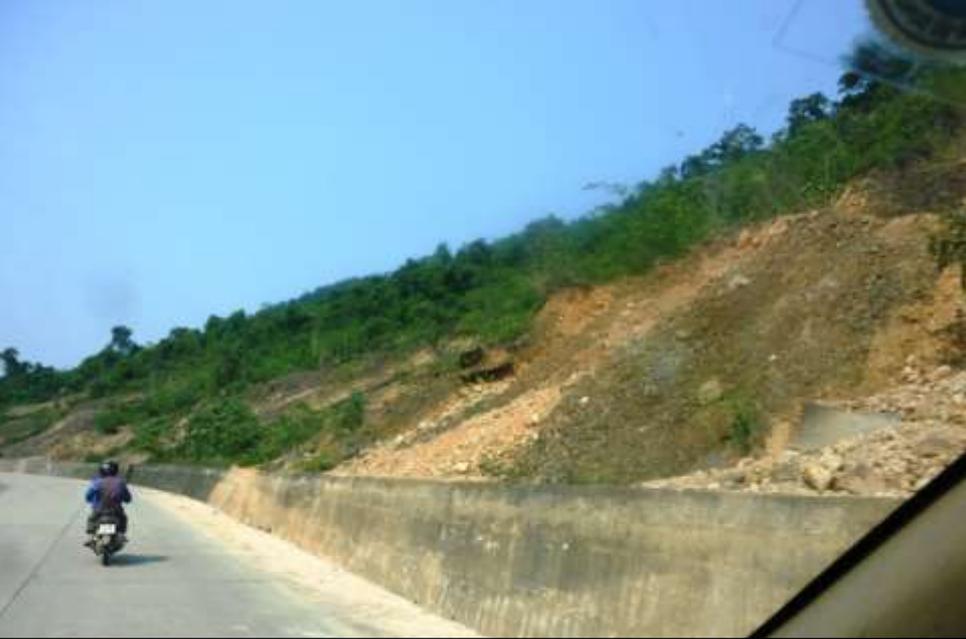
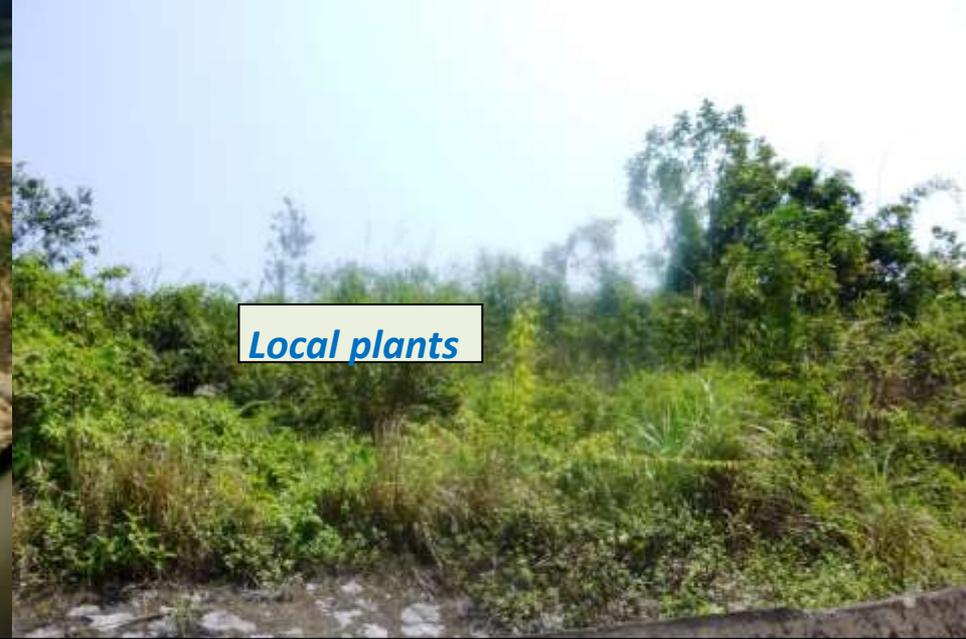
Local plants

*General view along the Highway in February 2014*

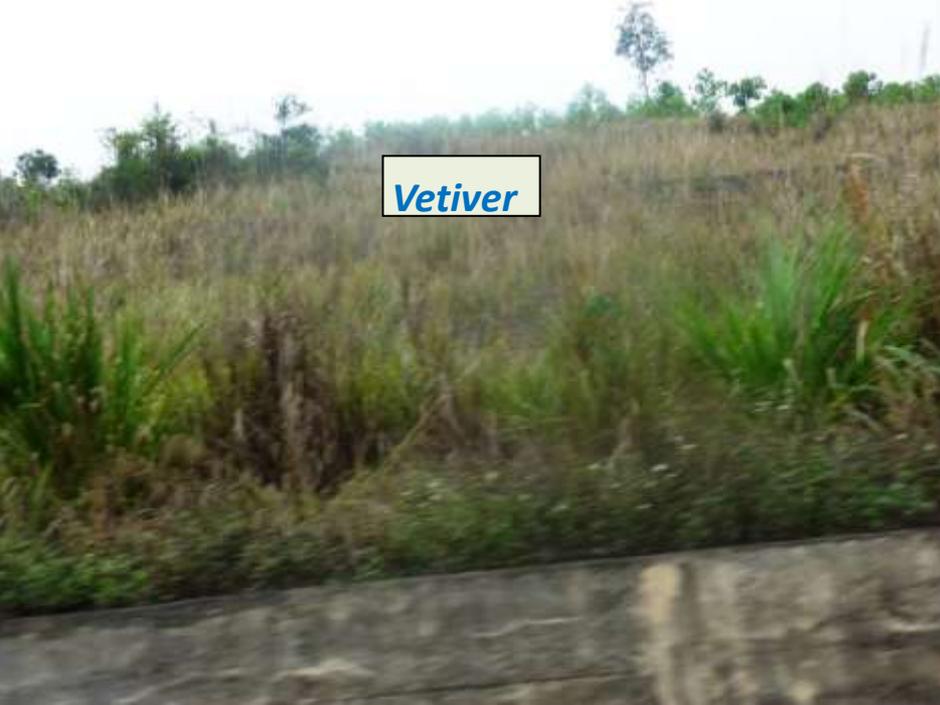
Vetiver
