# Ho Chi Minh Highway Fourteen Years Later

(2000- 2014)

*A Photo Essay on the Role of Vetiver System in Controlling Erosion on the Highway Following a Visit in February 2014*

**Dr. Paul Truong**

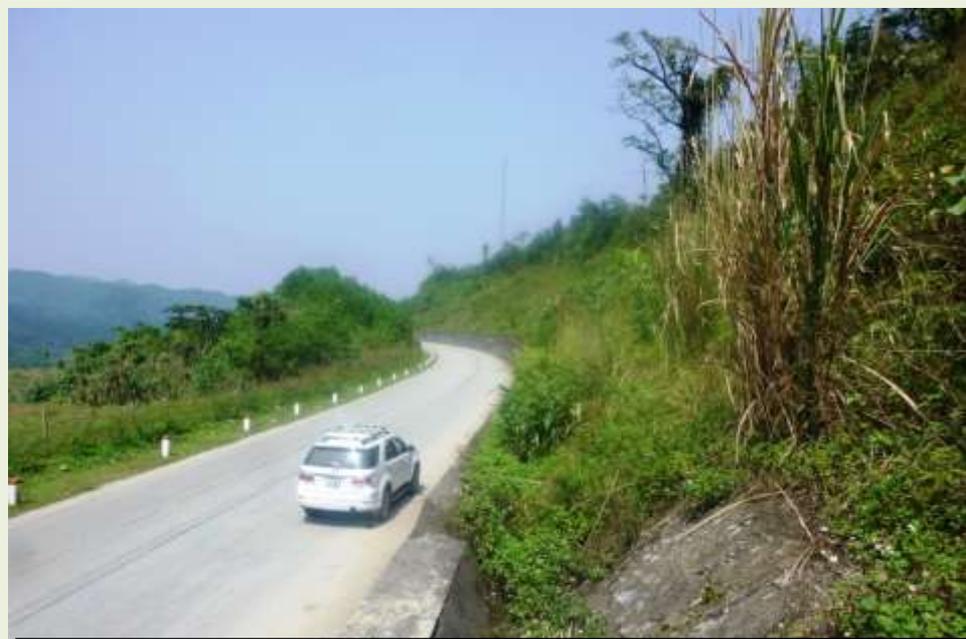
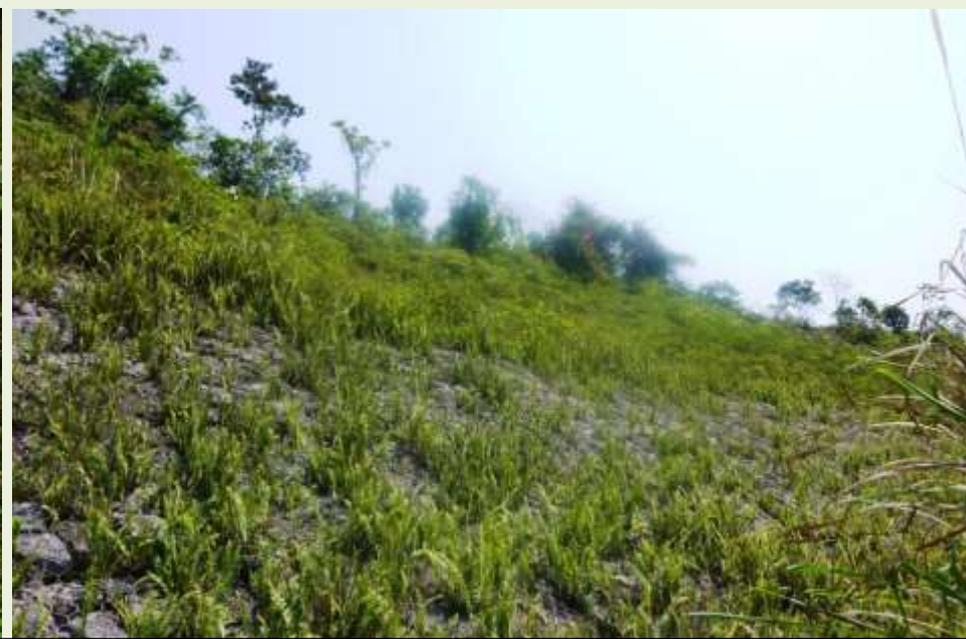
*General view along the Highway in 2014*

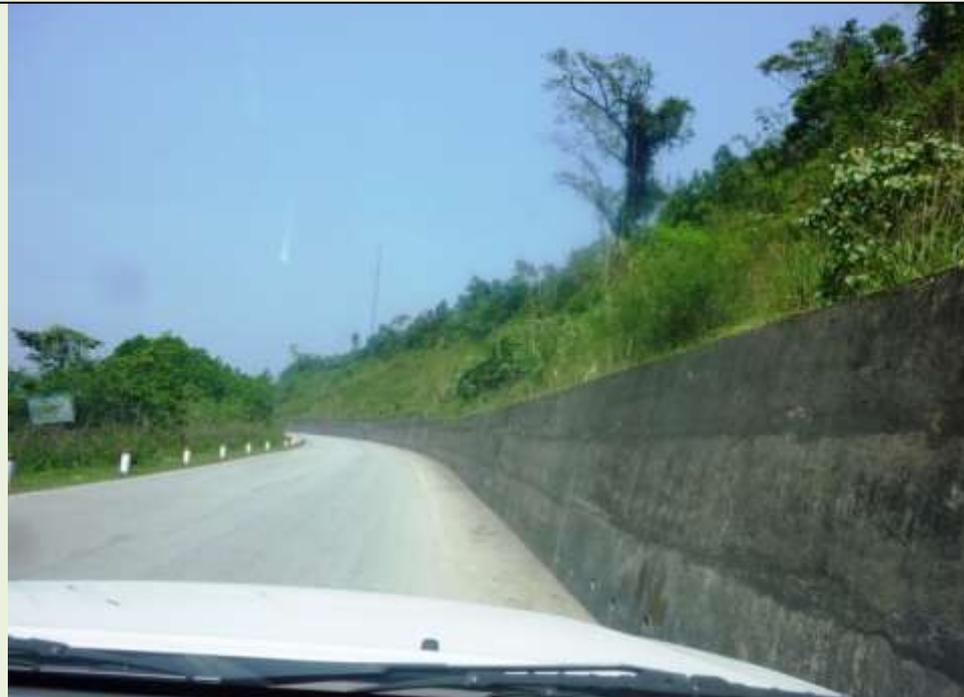
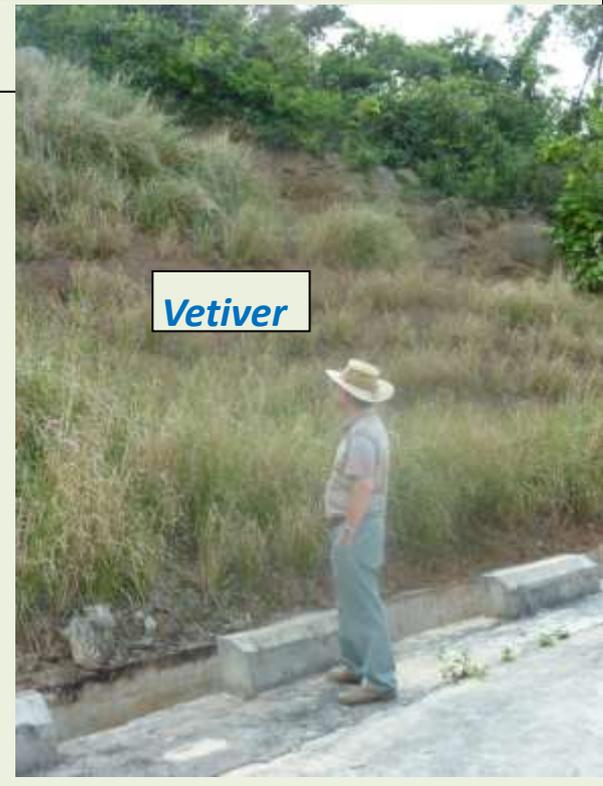
*Vetiver*

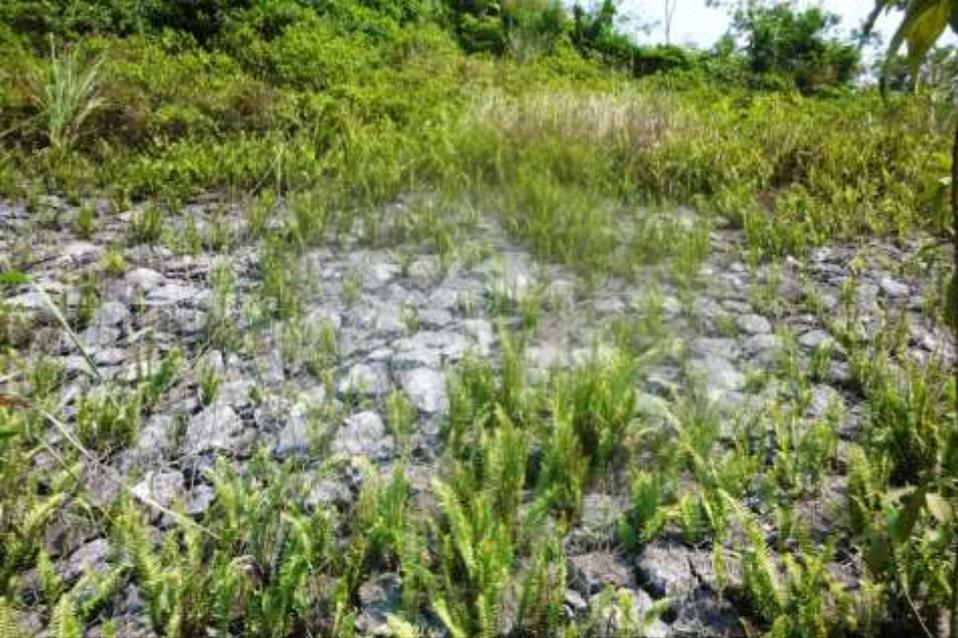
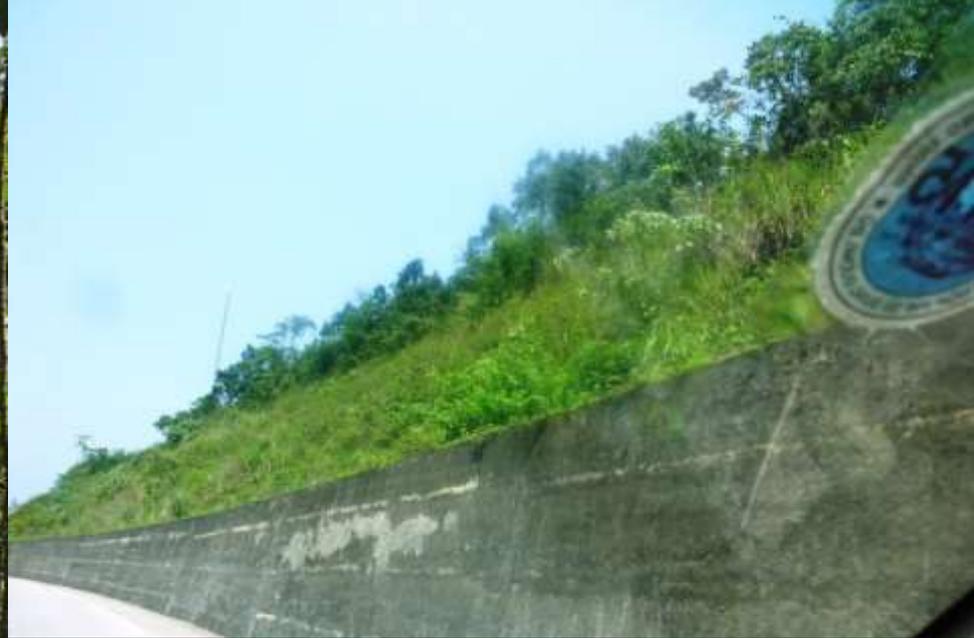
*General view along the Highway in February 2014*

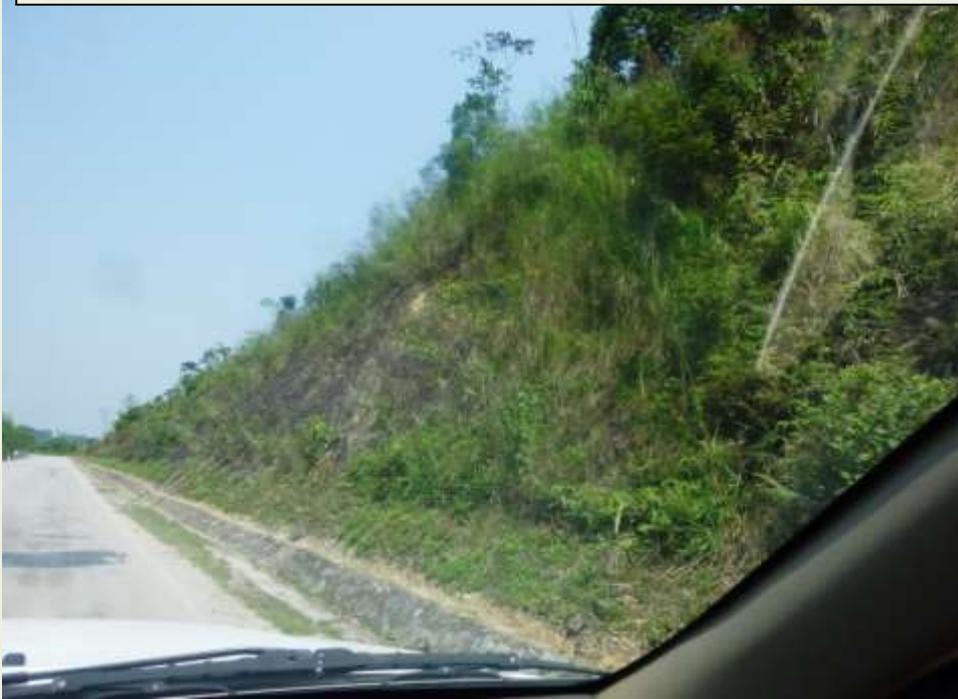
*Local plants*

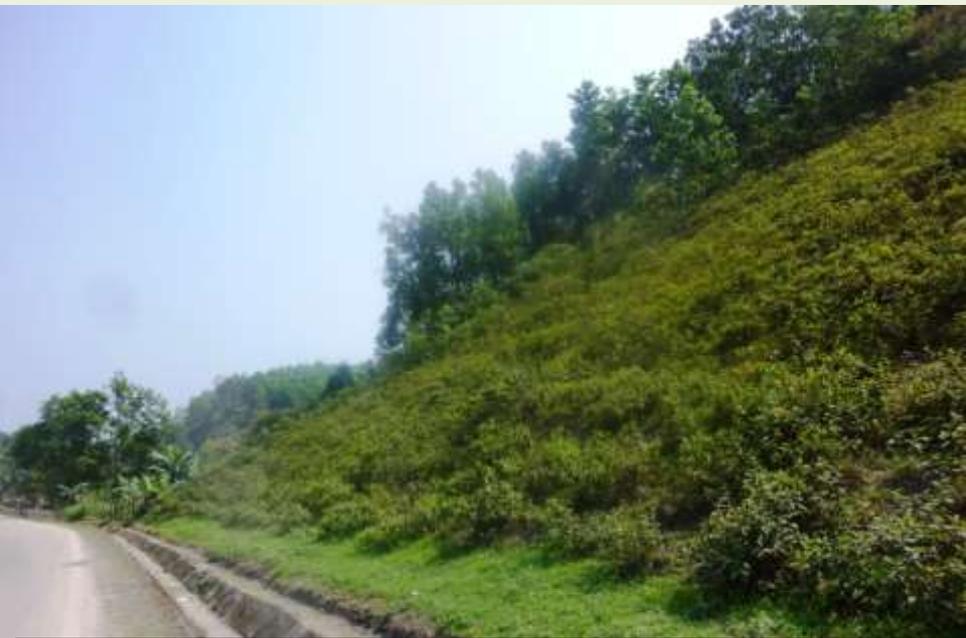
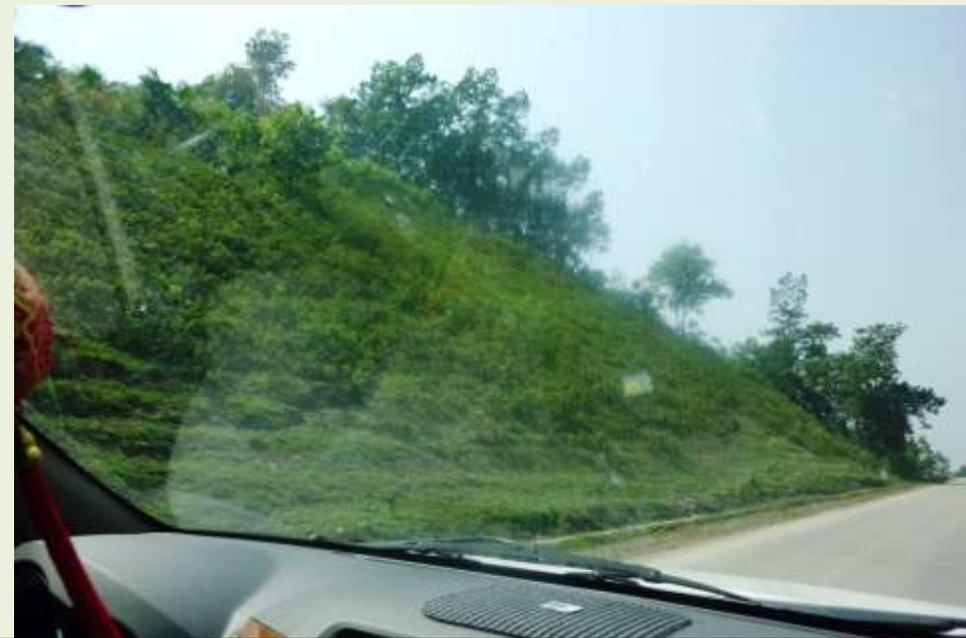
*General view along the Highway in February 2014*

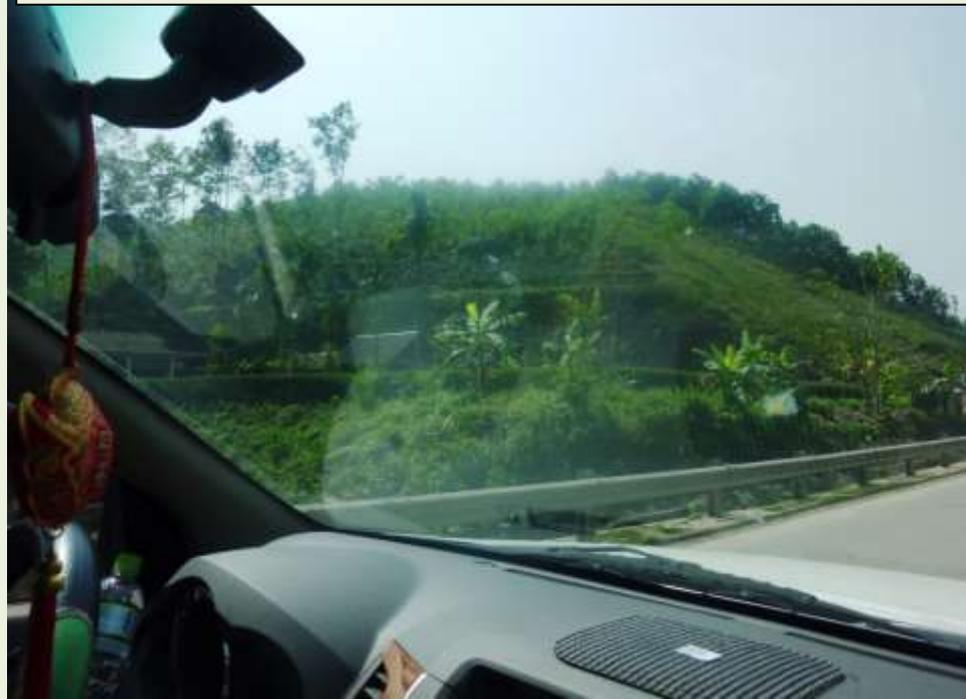
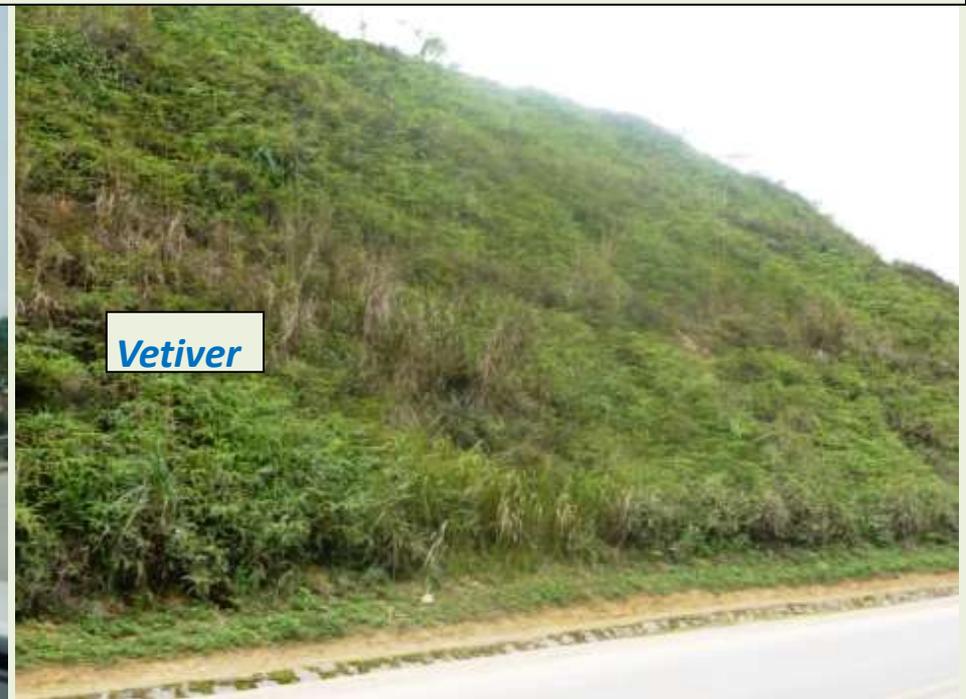
*Vetiver*

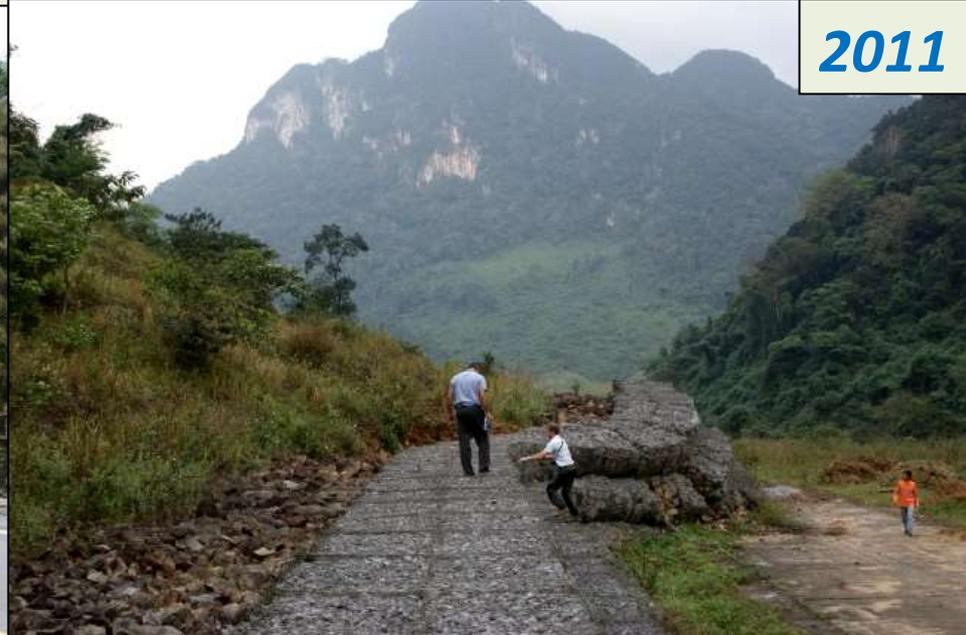
2011

*Vetiver*

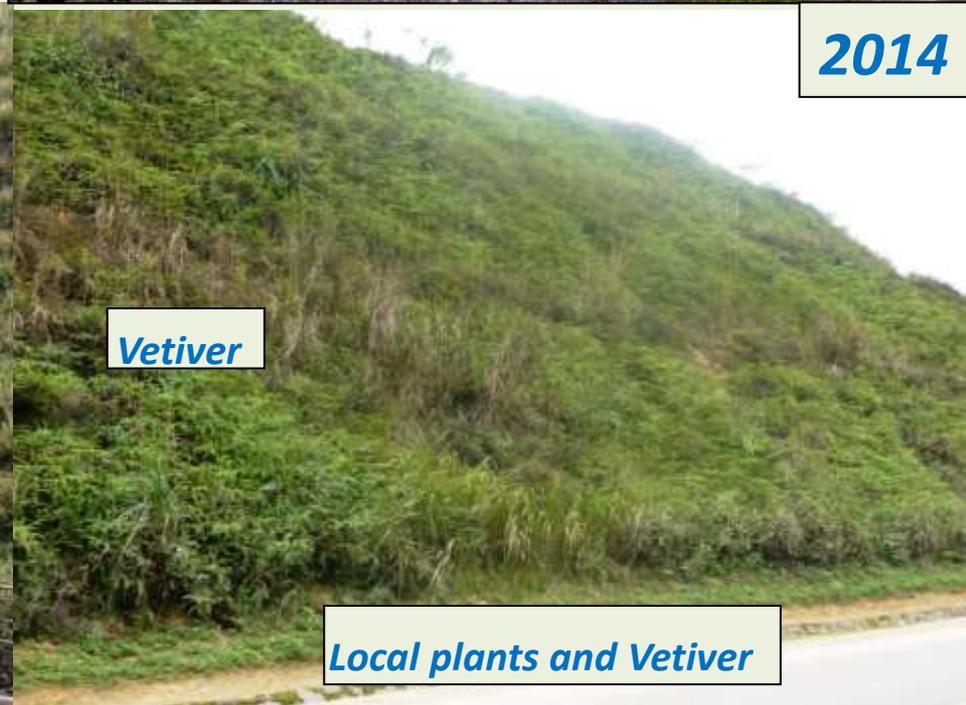
2014

*Local plants and Vetiver*

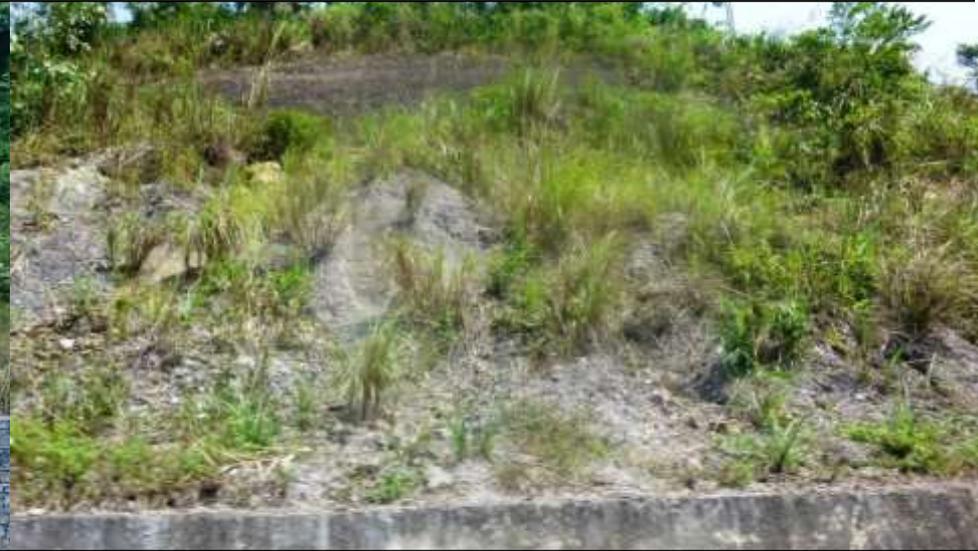
**2014**

*Local plants and Vetiver*

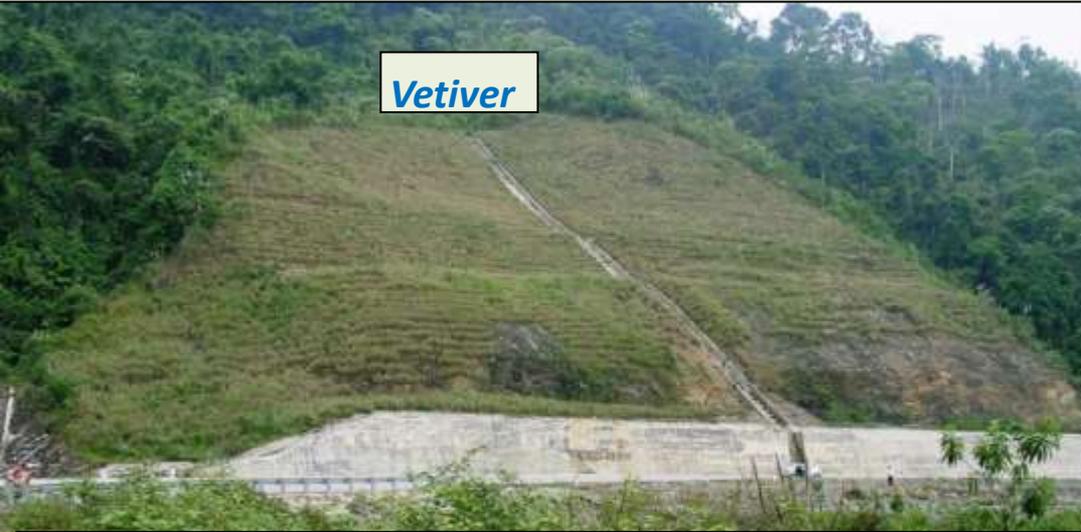
**2005**

*Vetiver*

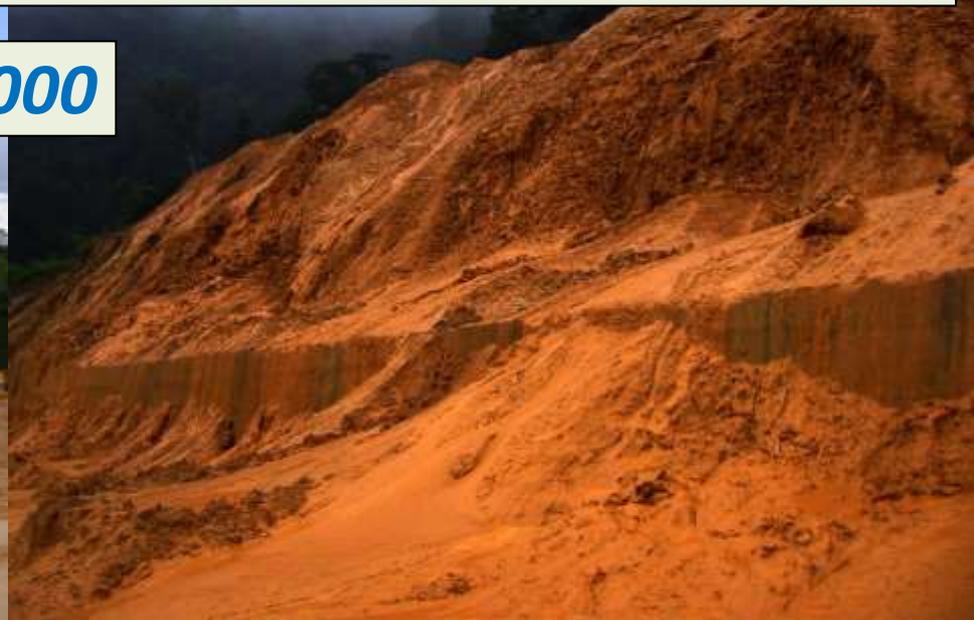
2014

*Local plants and Vetiver*

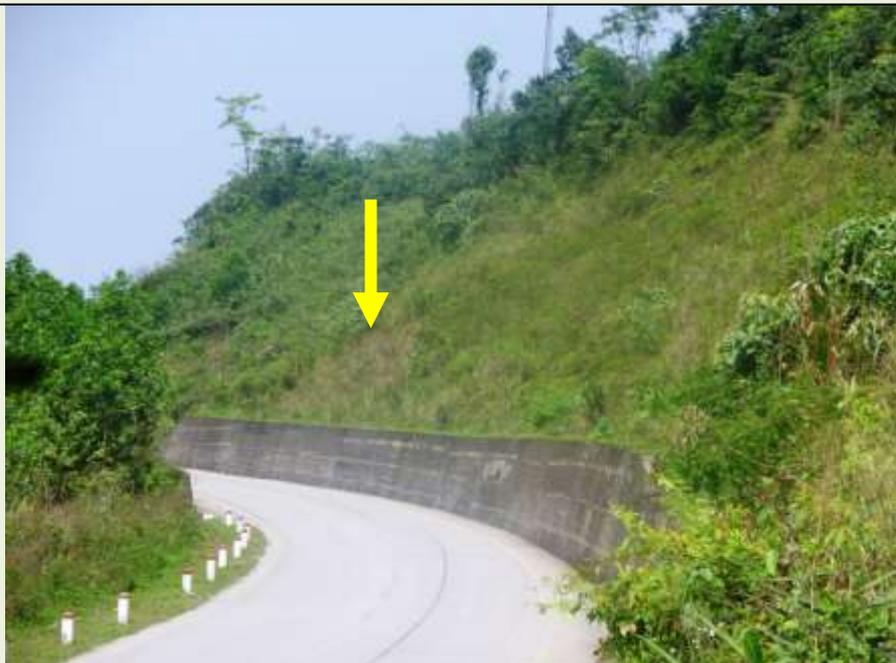
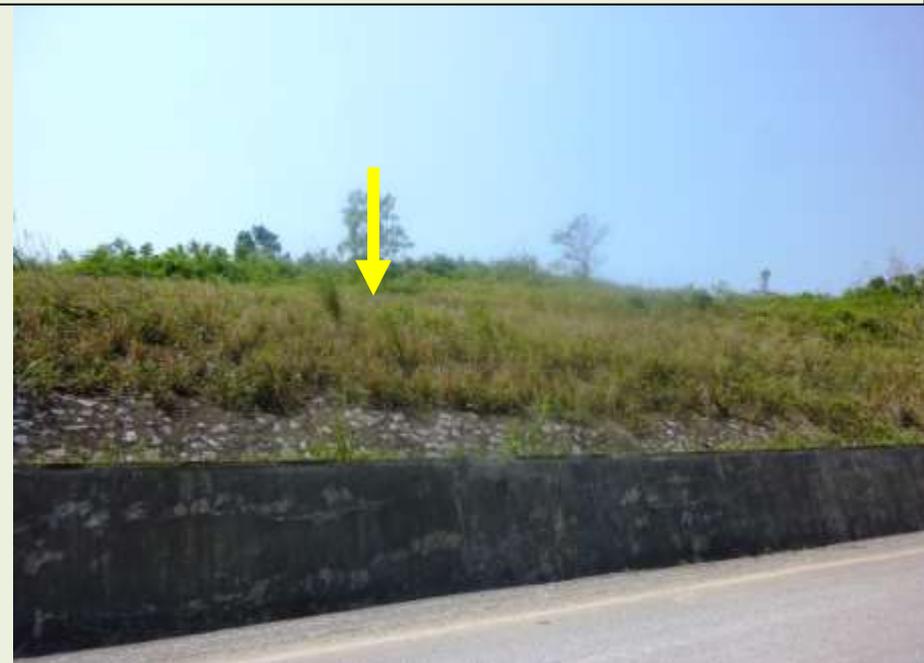
**In area where local species did not re-established, vetiver persisted and continue to provide protection**

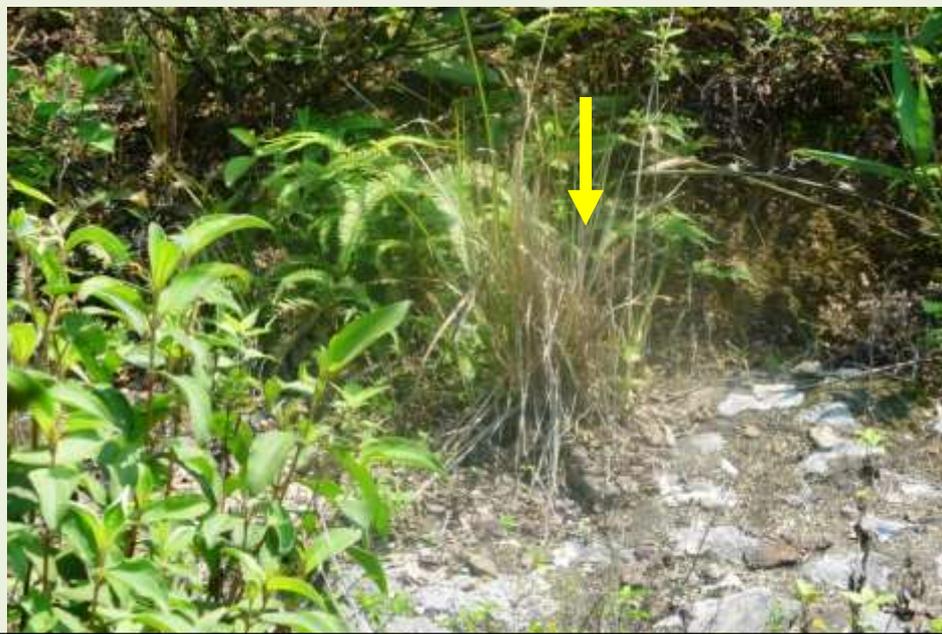
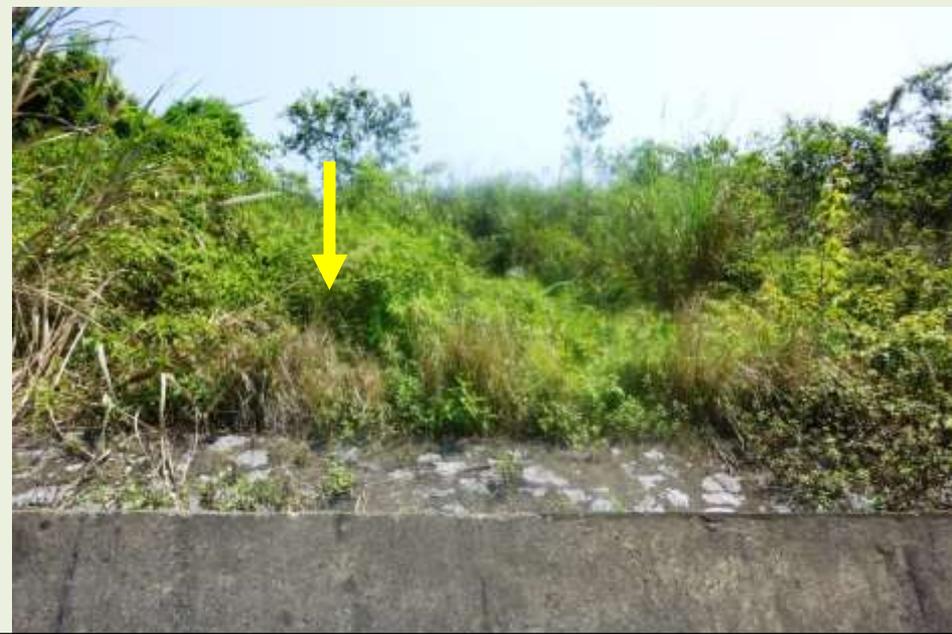
**It can be found mostly along the edges of the original planting**

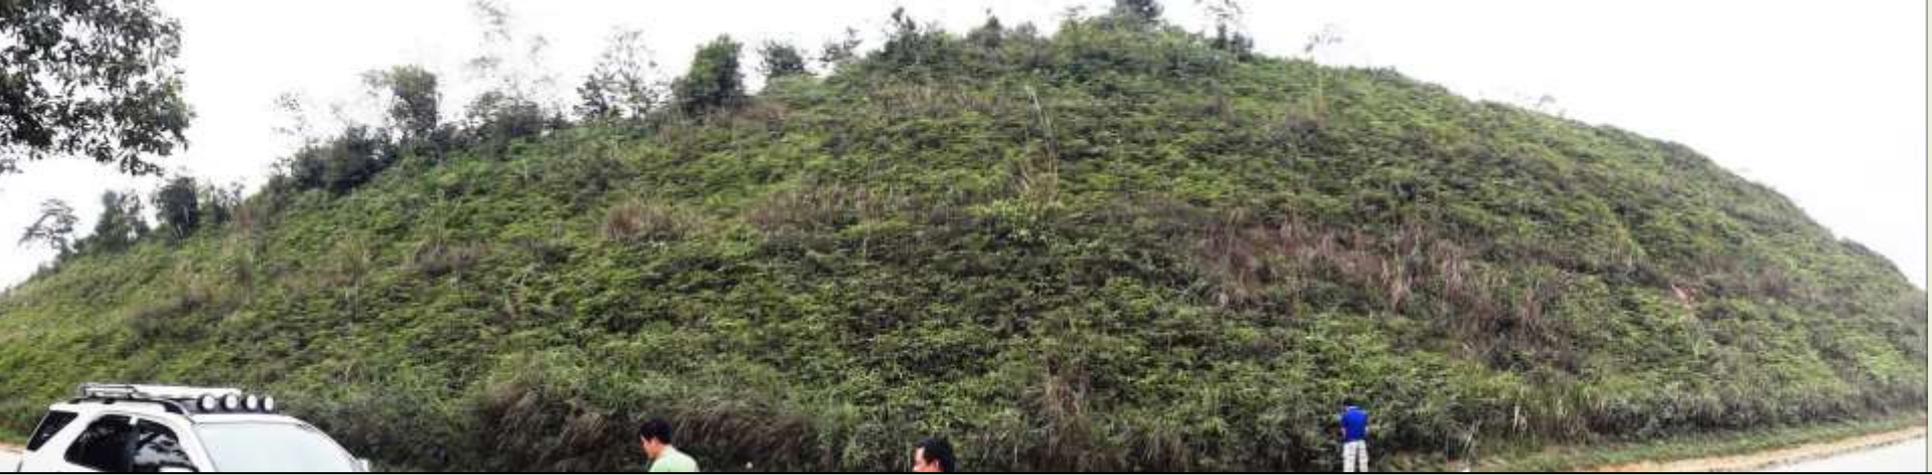
*2014 Some vetiver but mostly endemic plants*

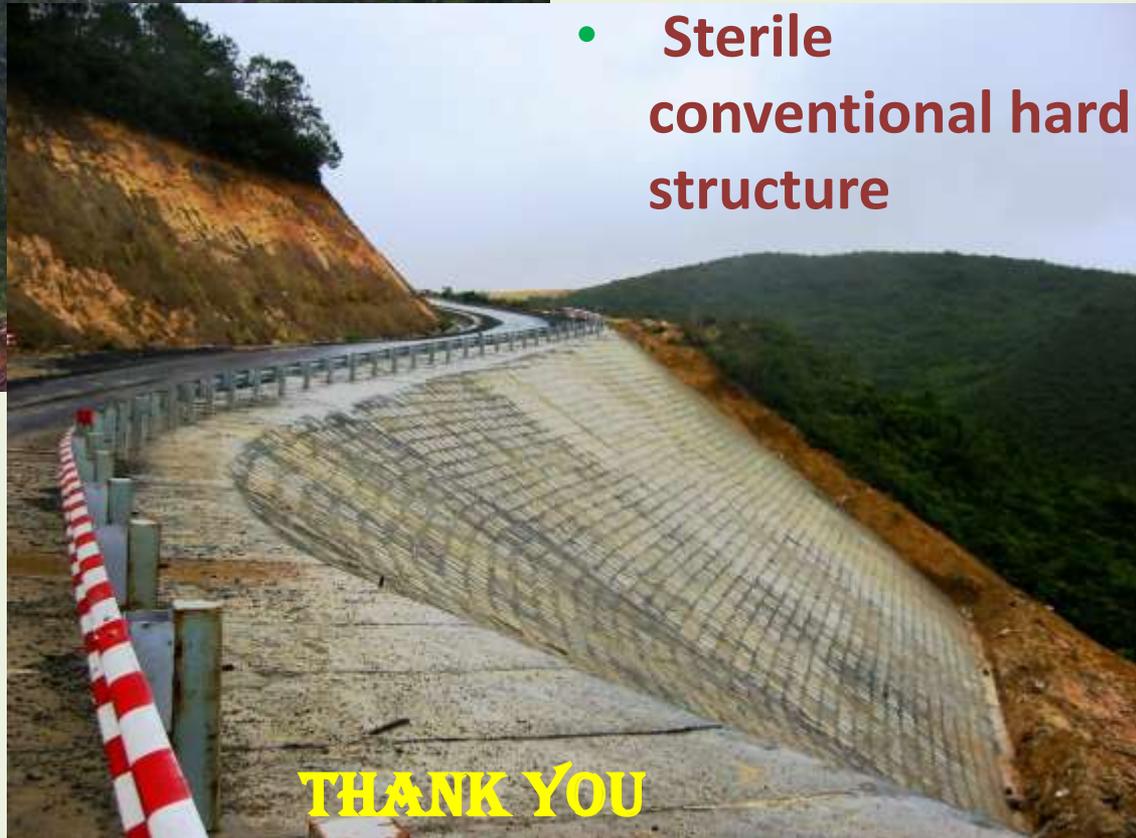
Equally effective in erosion control but definitely not equally effective in cost of establishment and long term maintenance
